## Experimental research on wall-hollow core slab connections

Requested by: Suomen Betonitieto Oy

**Task** **Experimental research on wall-hollow core slab connections**

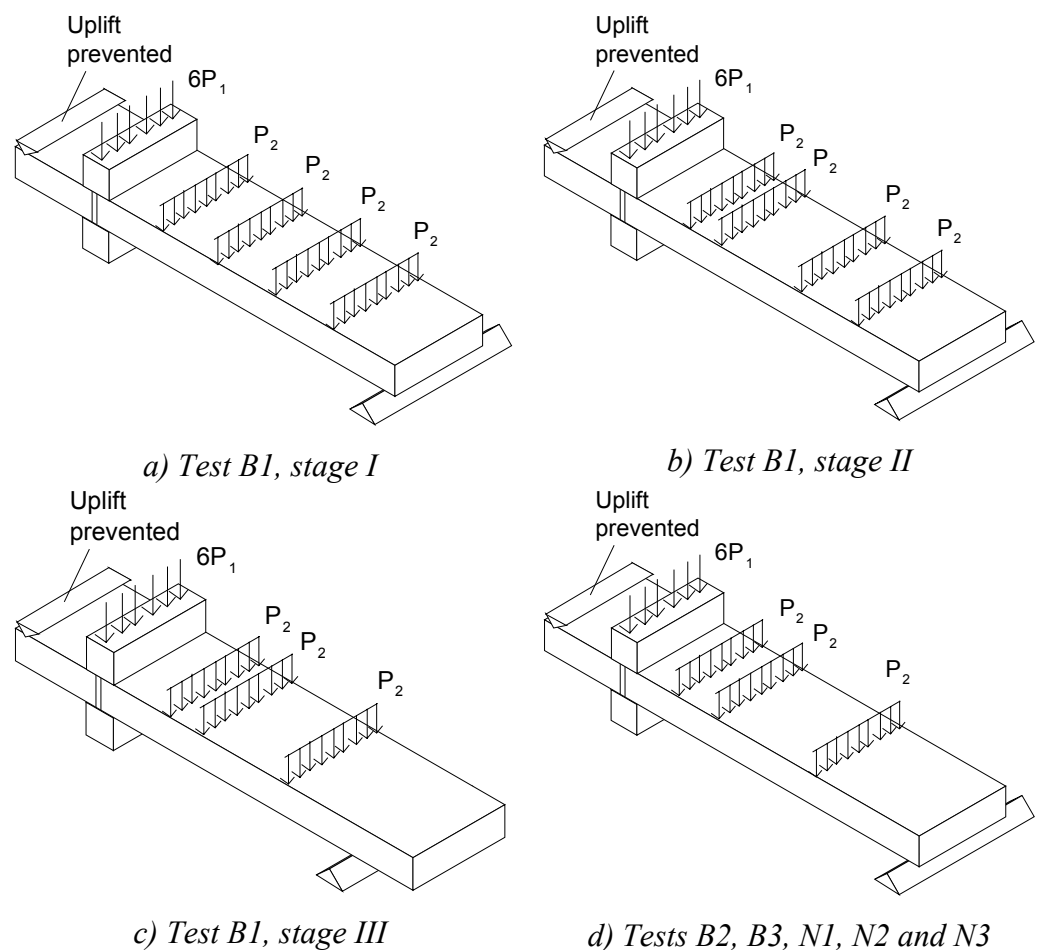
Fig. 2. Overview on test layout.  $P_1$  is kept constant ( $6P_1 = 1.6 \text{ MN}$ ) while  $P_2$  is increased until failure.

In Fig. 2.a the planned loading arrangements are illustrated. However, in the first test B1 the simply supported end of the slab failed, first locally, and then, after rearrangement of the loads as shown in Fig. 2.b, globally. Therefore, a third test layout illustrated in Fig. 2.c was used to make the slab fail at the clamped end. The loads for the remaining five tests are shown in Fig. 2.d.

Six load tests were performed, see Fig. 2. Three tests (B1, B2 and B3) simulated a Finnish BES connection, three tests (N1, N2 and N3) a connection with notched slab ends. The latter connection type is widely used in Sweden.

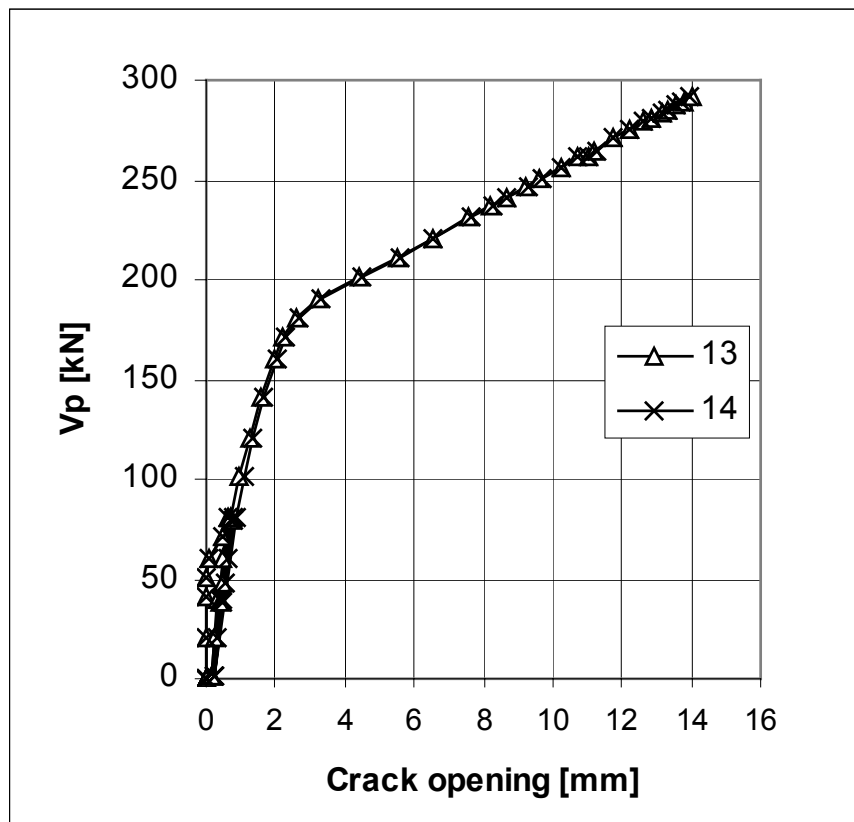
Fig. 46. Width of flexural crack at slab end next to the connection measured by transducers 13 and 14 in test B3.

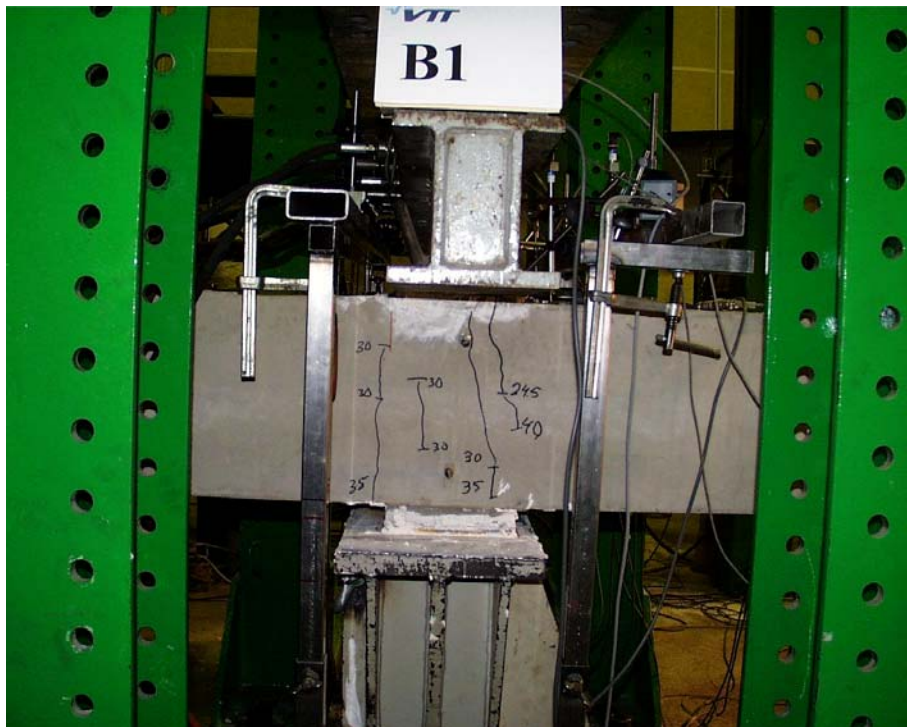
*Fig. 10. B1.I, North edge. First cracks.*

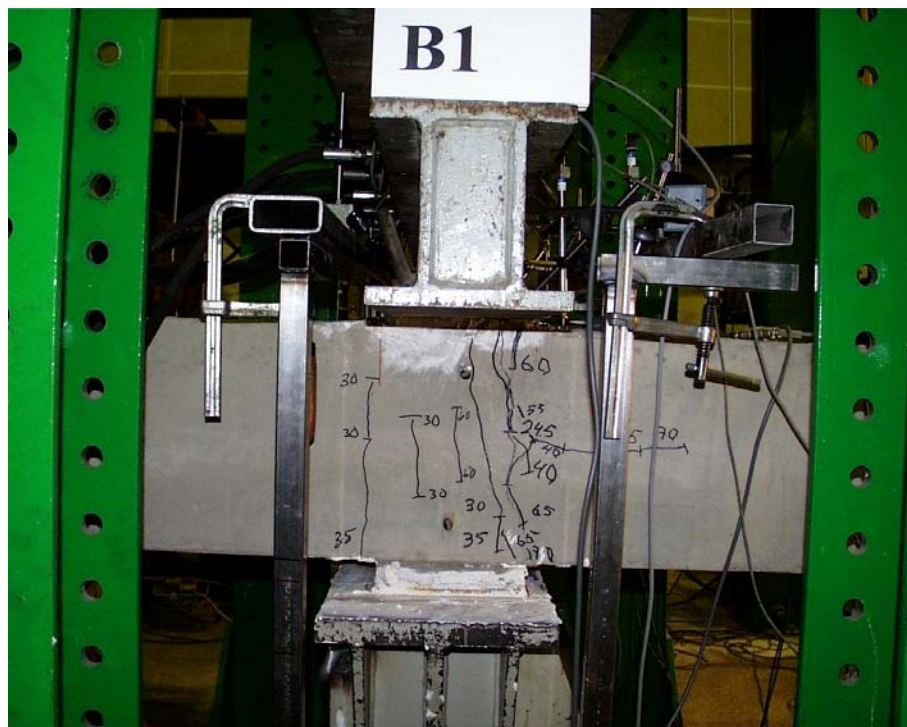
*Fig. 12. B1.III, North edge. Cracks before failure.*

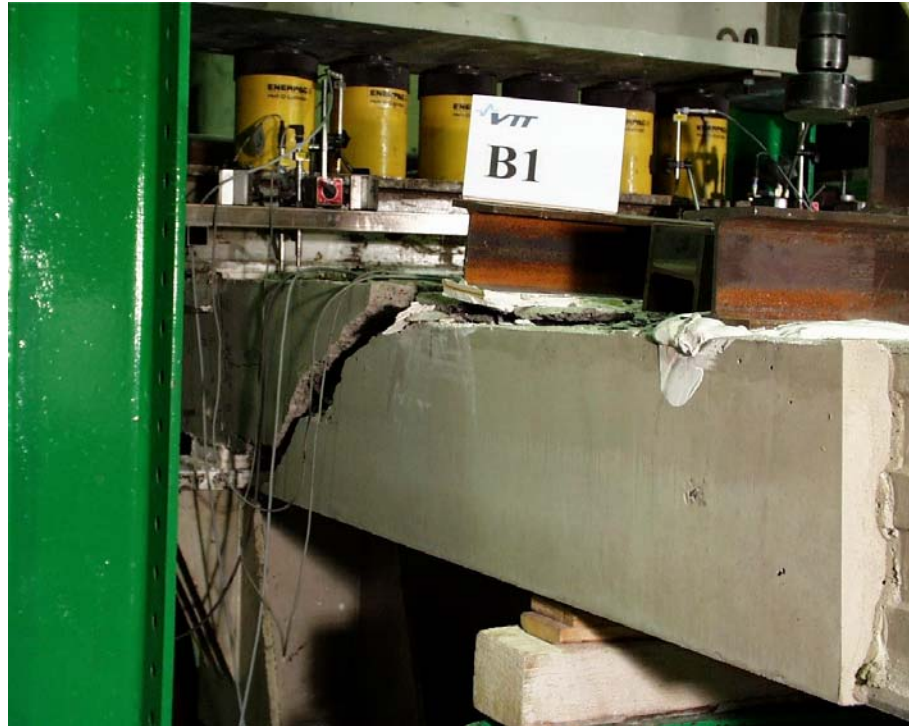
*Fig. 15. B1.III. North edge after failure.*

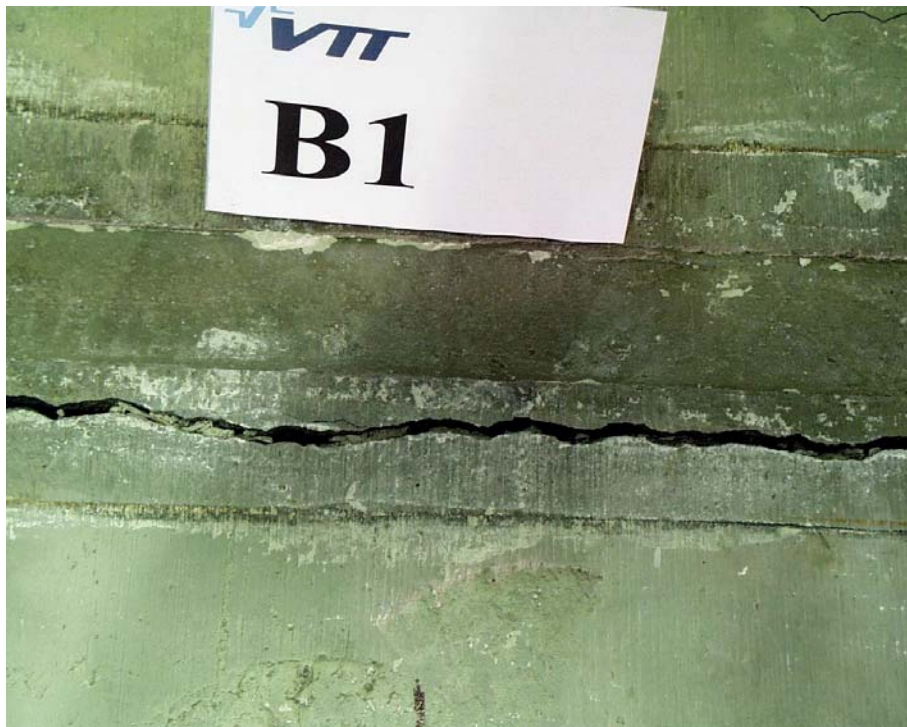
*Fig. 20. B1.III. Top surface after failure. Note that the slab end is cracked, not the joint concrete.*

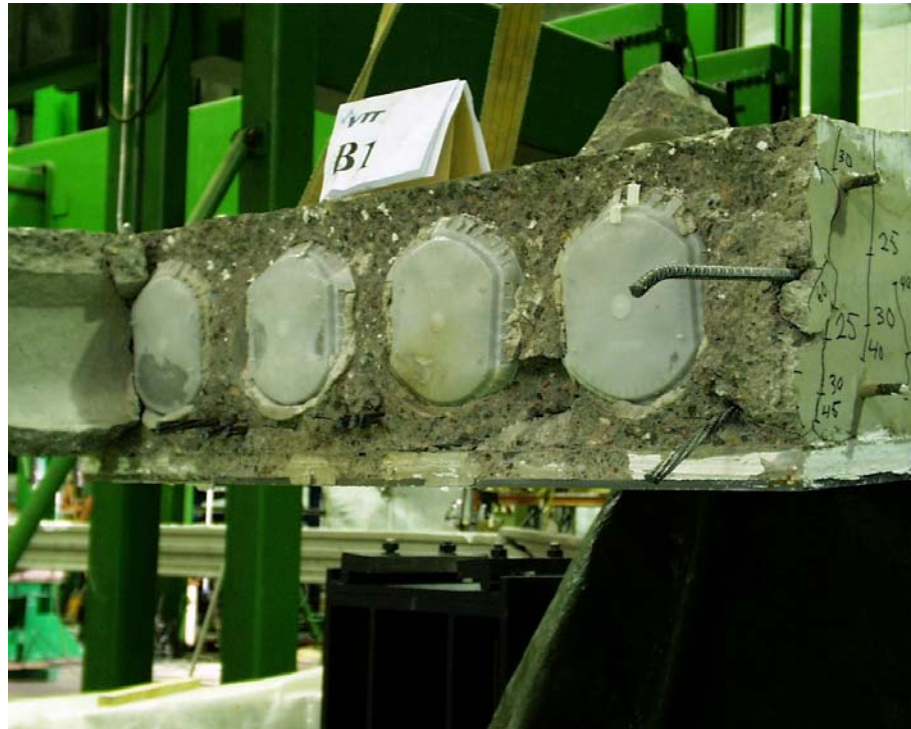
Fig. 21. B1.III. Flexural crack after flame cutting the strands and tie bars.

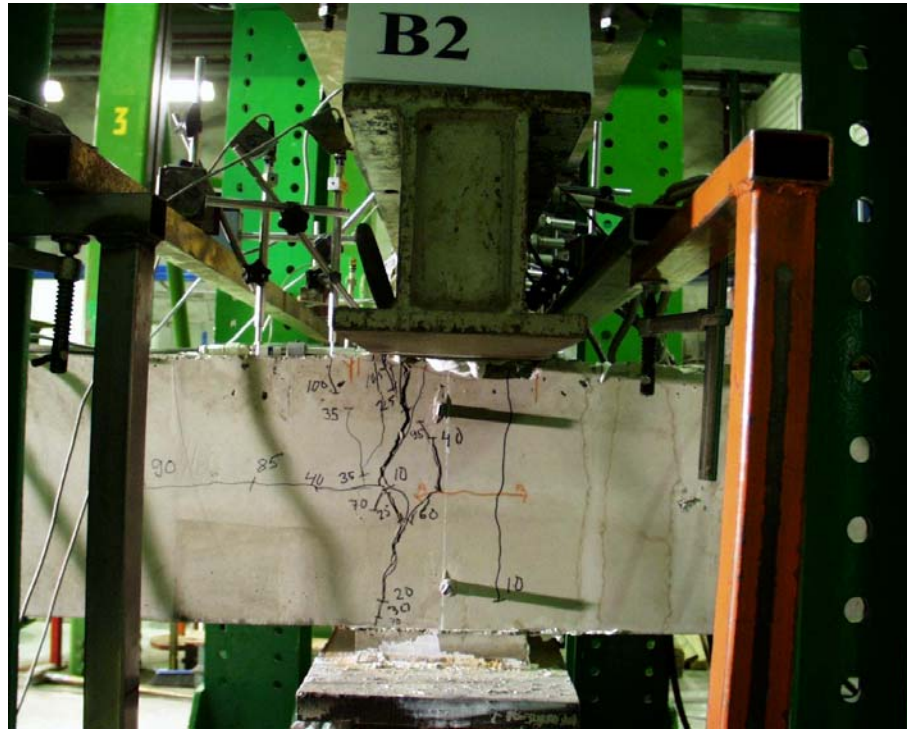
*Fig. 27. B2, South edge. Cracks before failure.*

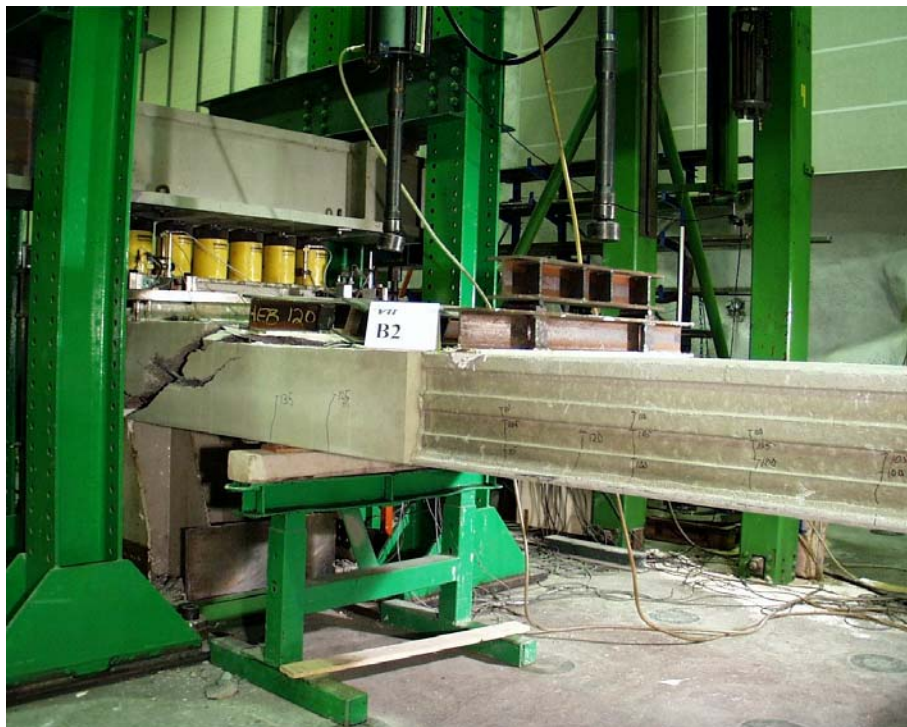
*Fig. 32. B2. Flexural cracks.*

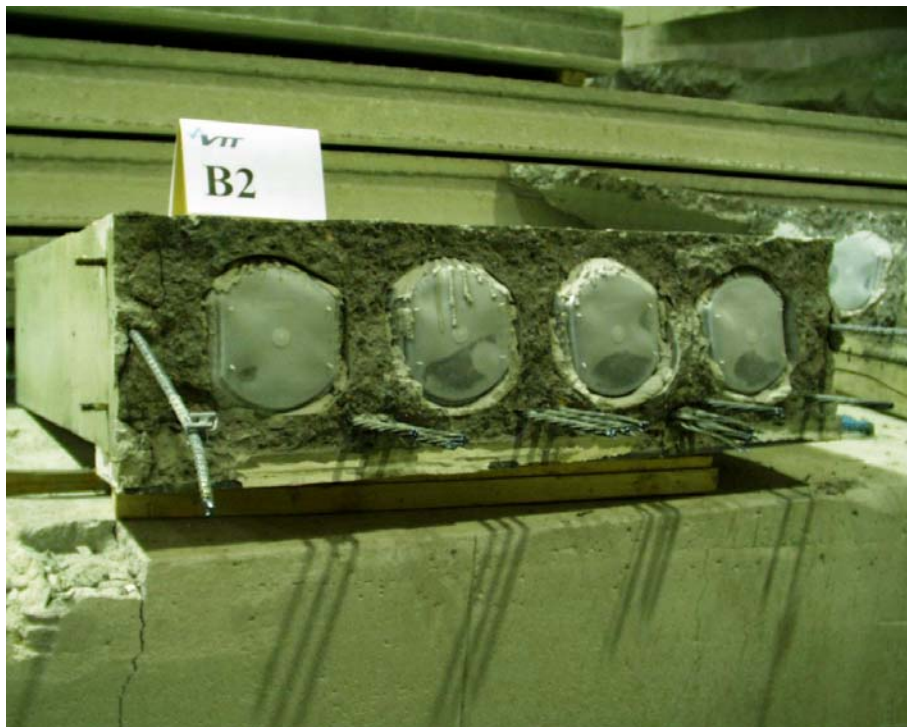
*Fig. 34. B2. Flexural crack after flame cutting the strands and the tie bars.*

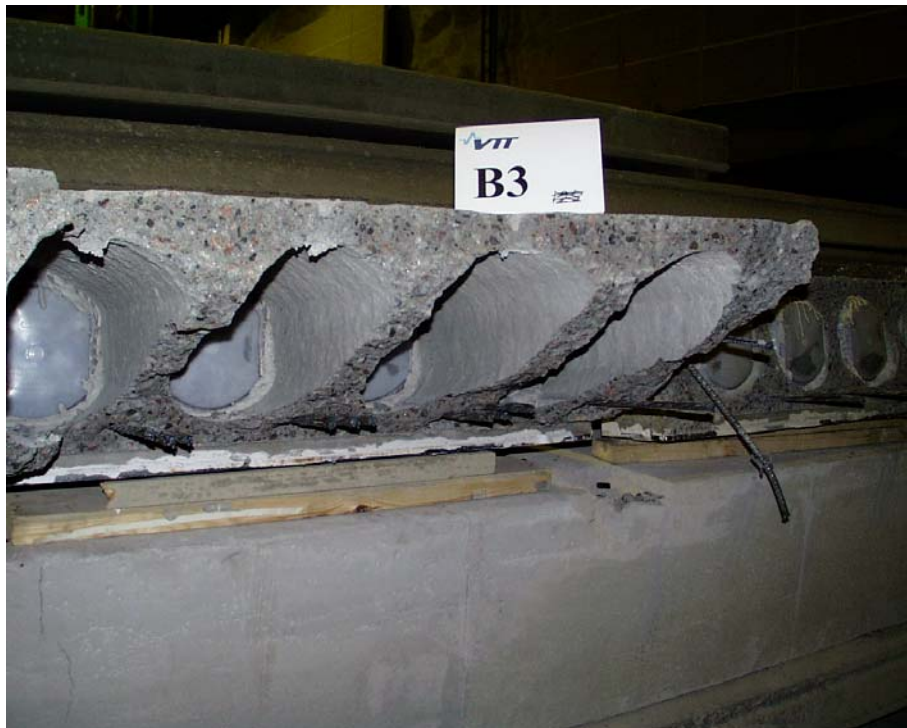
*Fig. 46. B3. Shear crack after flame cutting the strands and tie bars.*

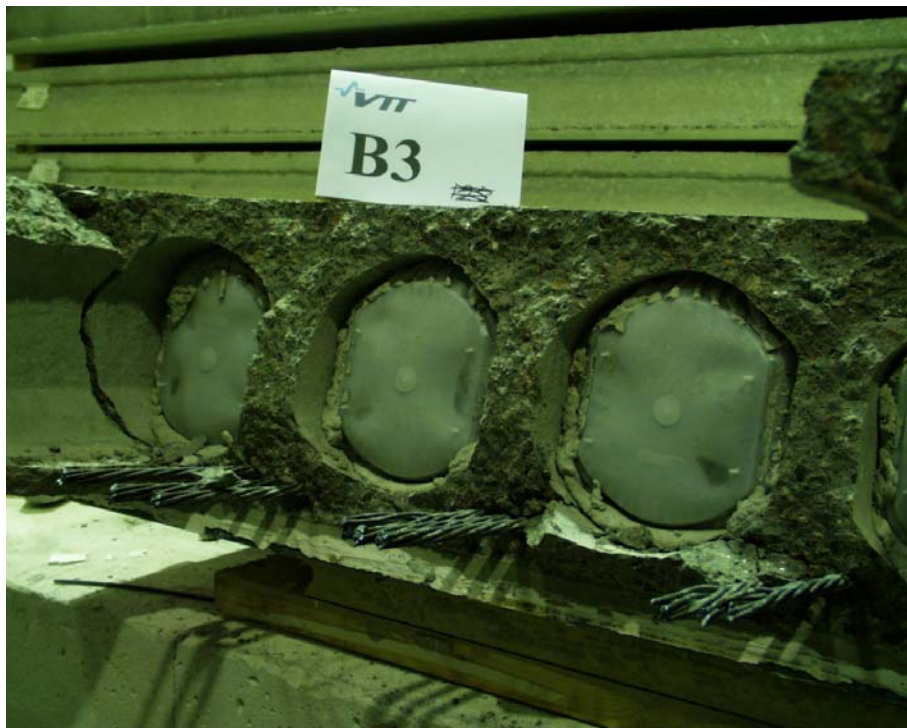
*Fig. 48. B3. Detail of flexural crack.*

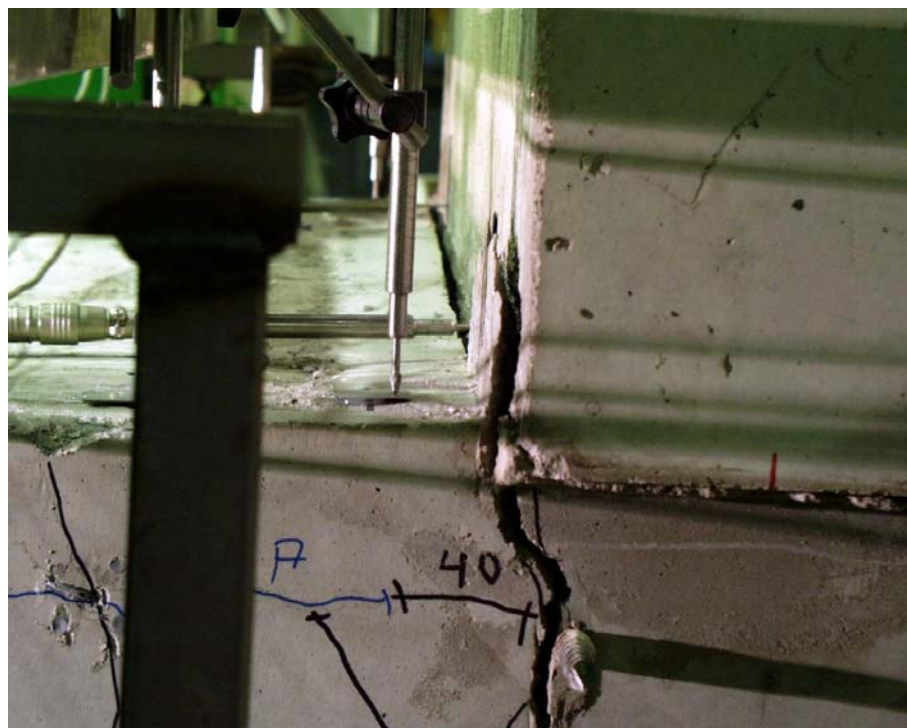
*Fig. 12. N1, South edge. Flexural crack before failure.*

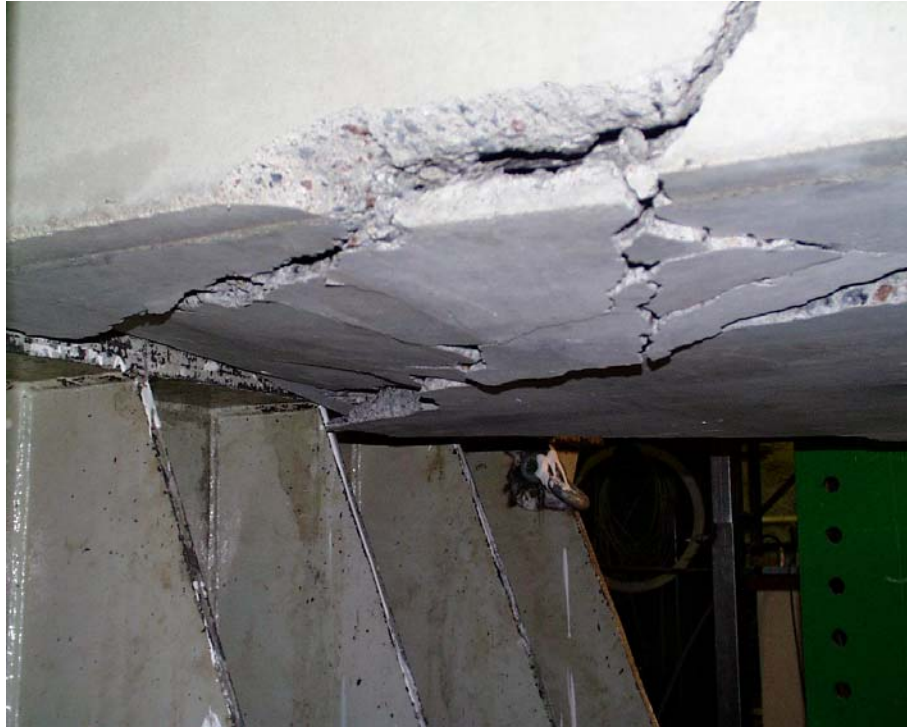
*Fig. 17. N1. Soffit after failure.*

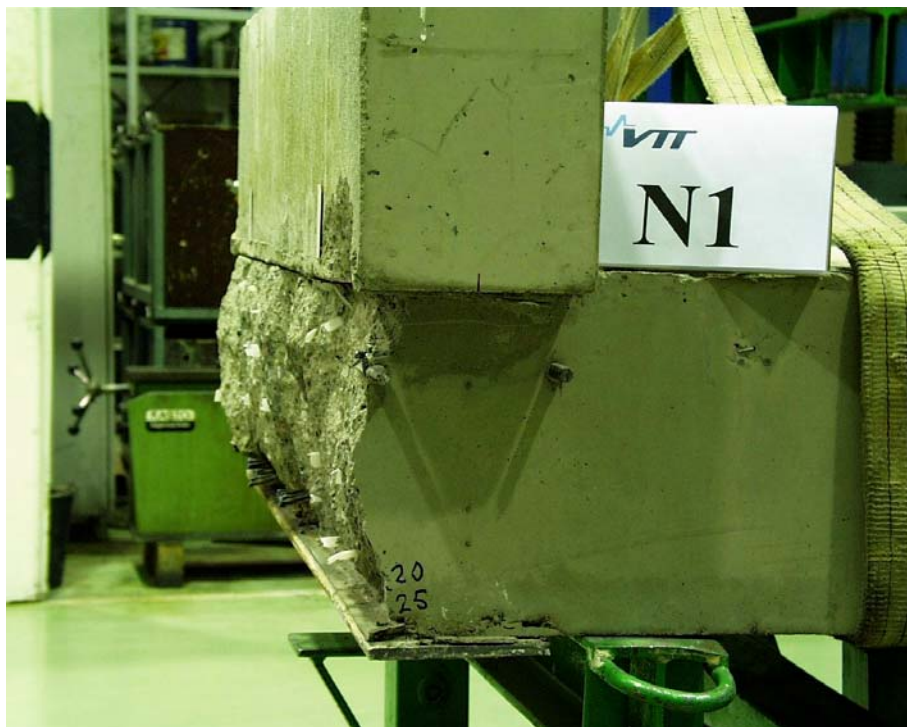
*Fig. 22. N1. Vertical crack.*

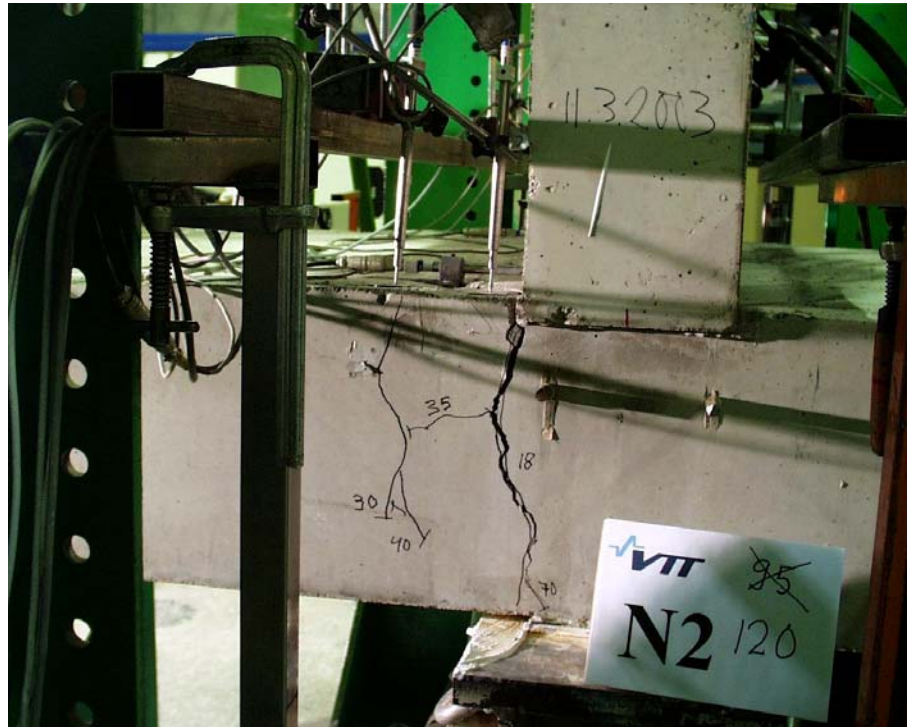
*Fig. 25. N2, South edge. Cracks before failure.*

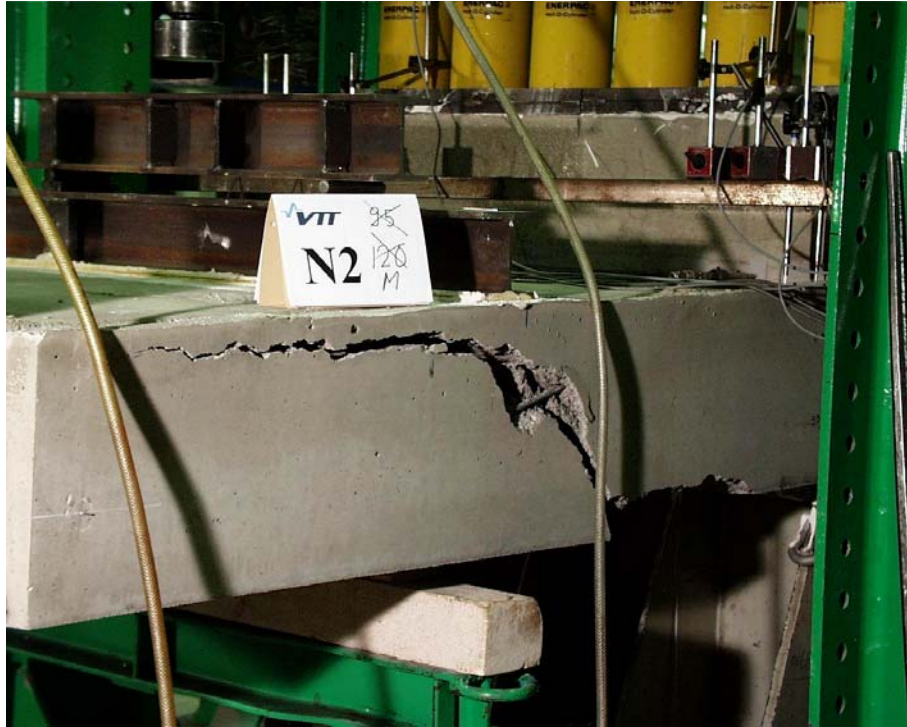
*Fig. 29. N2, South edge. Failure crack.*

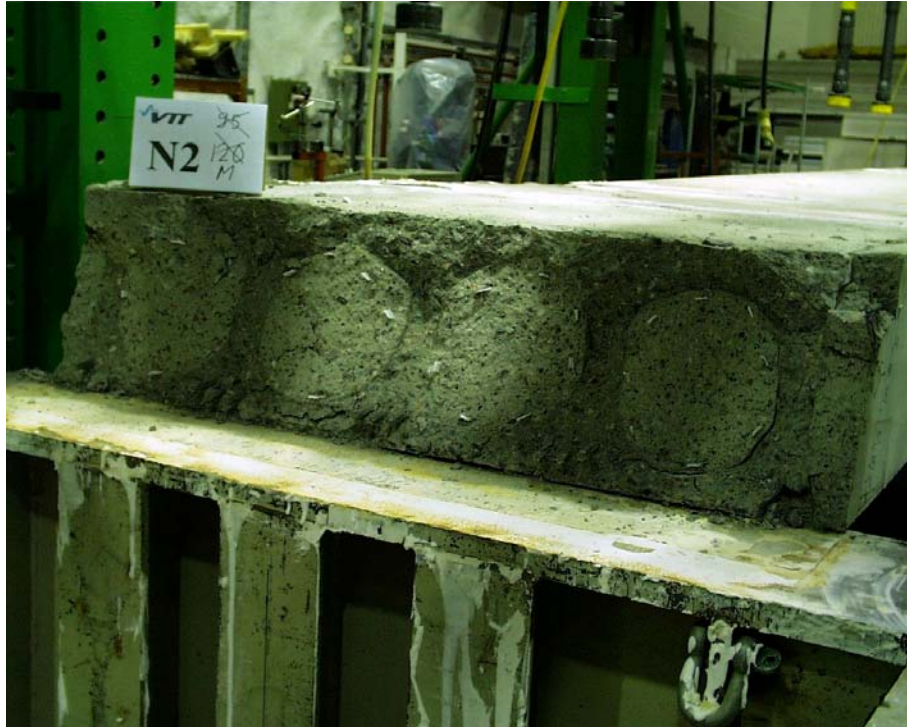
*Fig. 33. N2. Flexural crack.*

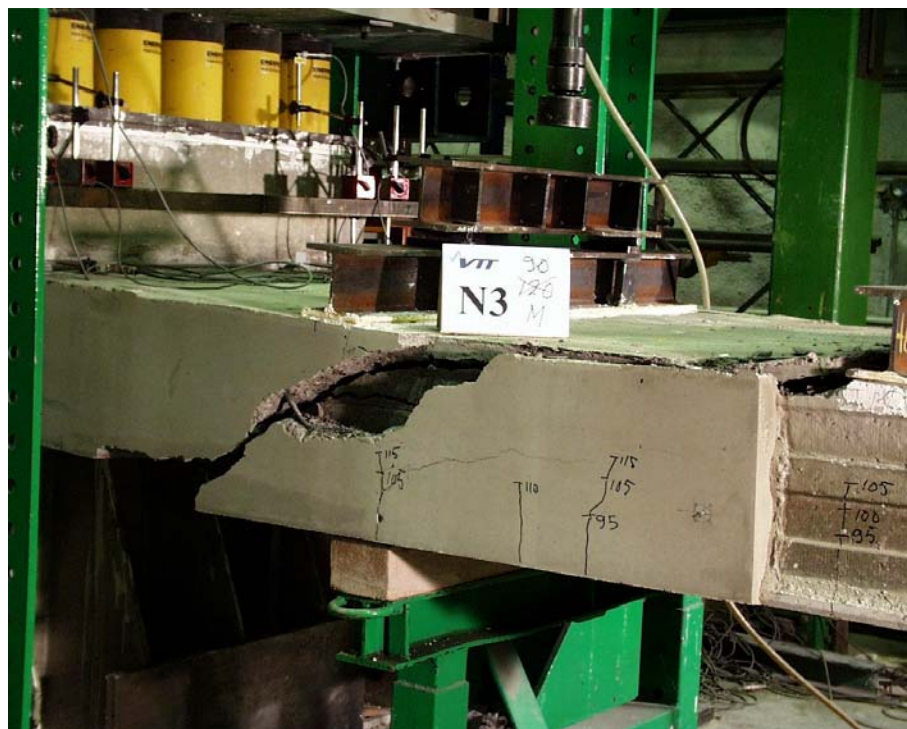
*Fig. 40. N3, North edge. Failure crack and flexural cracks.*

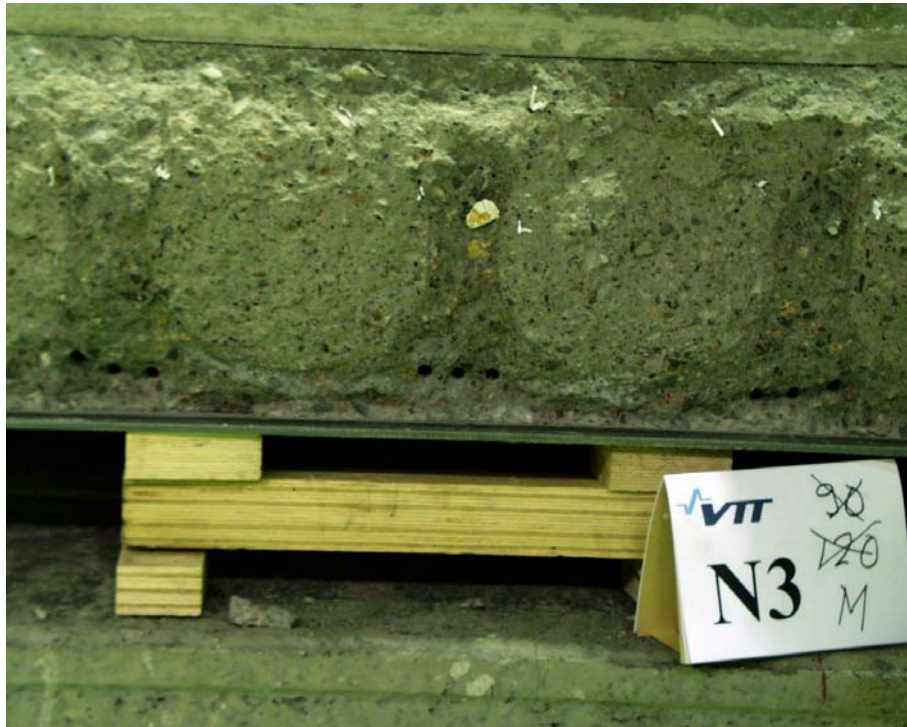
*Fig. 47. N3. Detail of flexural crack.*

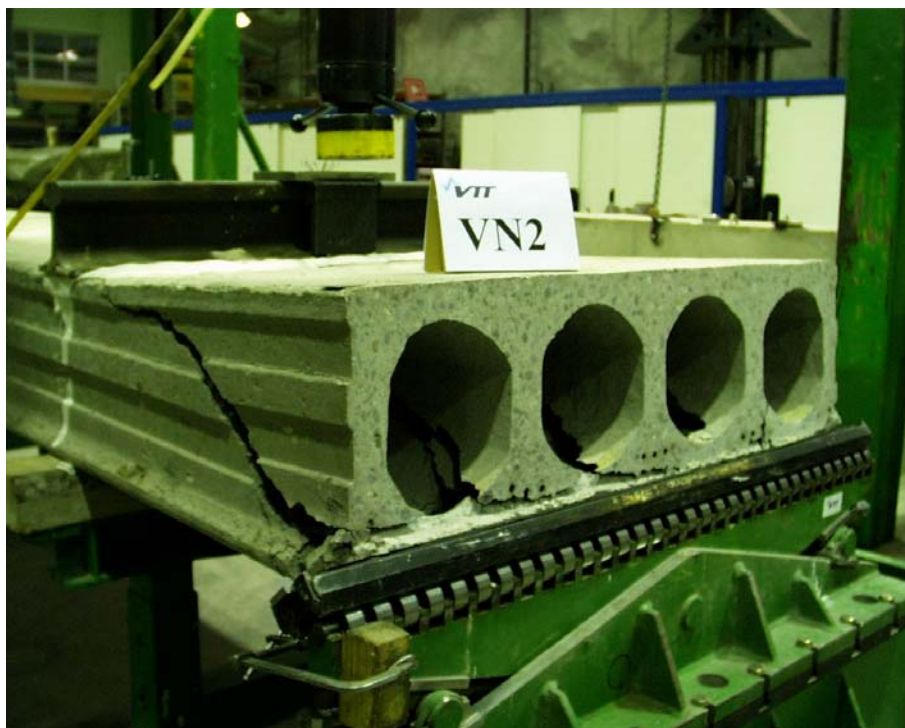
*Fig. 4. VN2. South edge after failure.*

The failure mode in both reference tests was shear tension failure, see App. C. The observed shear resistance (shear force next to the support) is given in Table 7. In Table 7 also the predicted resistances calculated according to Eurocode 2 (prEN 1992-1-1, Draft April 2002) are given for both test specimens. Neither the hollow core standard prEN 1168 nor Eurocode 2 give advice for transforming the core strength into 150 mm cylinder strength  $f_{ck,C150}$ . Here it has been assumed that
