RESEARCH REPORT NO. RTE77/02

Experimental research on wall-slab connections

Requested by: Rakennustuoteteollisuus r.y.

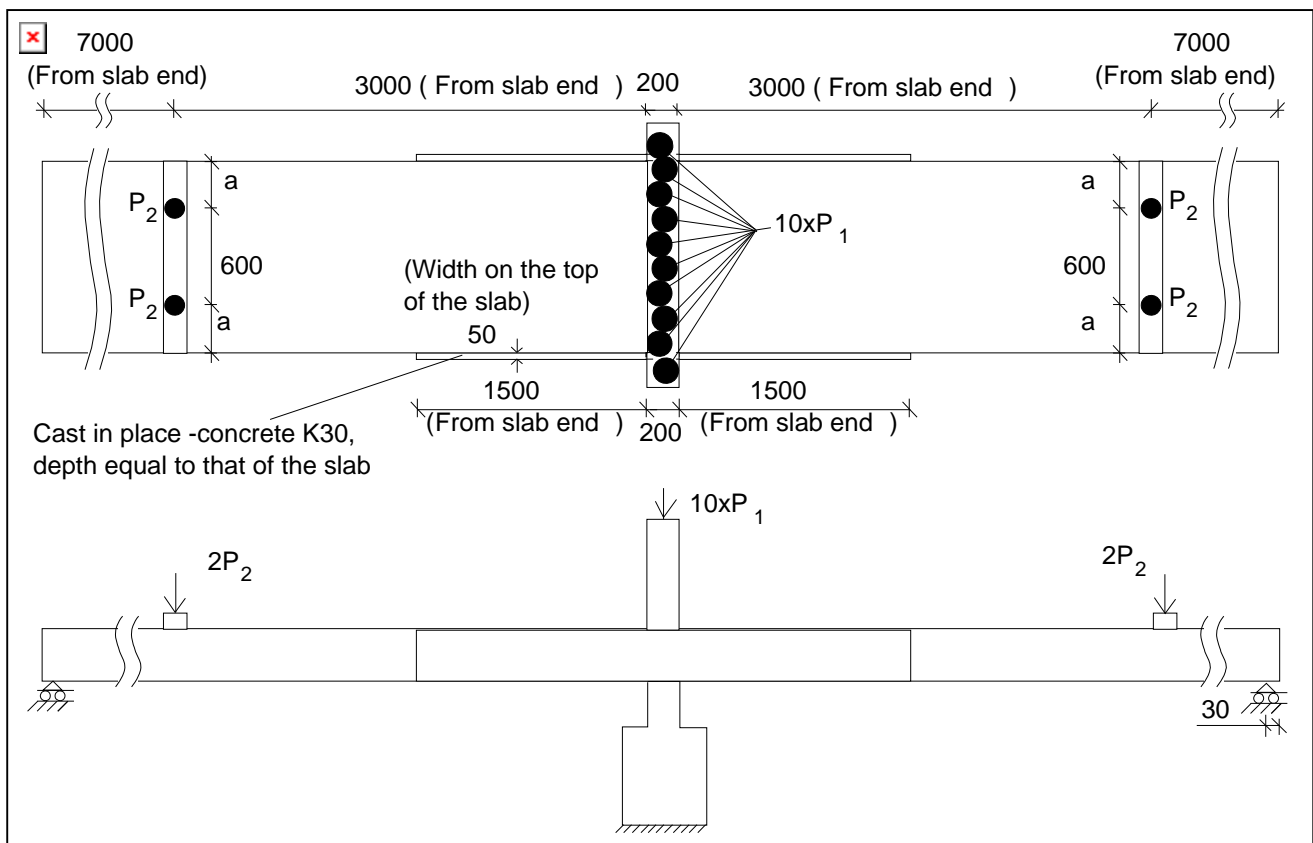
In Fig. 10 the location of the actuators and supports is given. In tests N1 and N2 there were two steel plates 50x275x480 mm³ above the upper wall element and under the outermost actuators in order to even out local stress concentrations.

Fig. 10. Loads.

The total load F_j on the joint is obtained from

$$F_j = \sum P_1 + \text{weight of upper wall} + \text{weight of loading equipment}$$

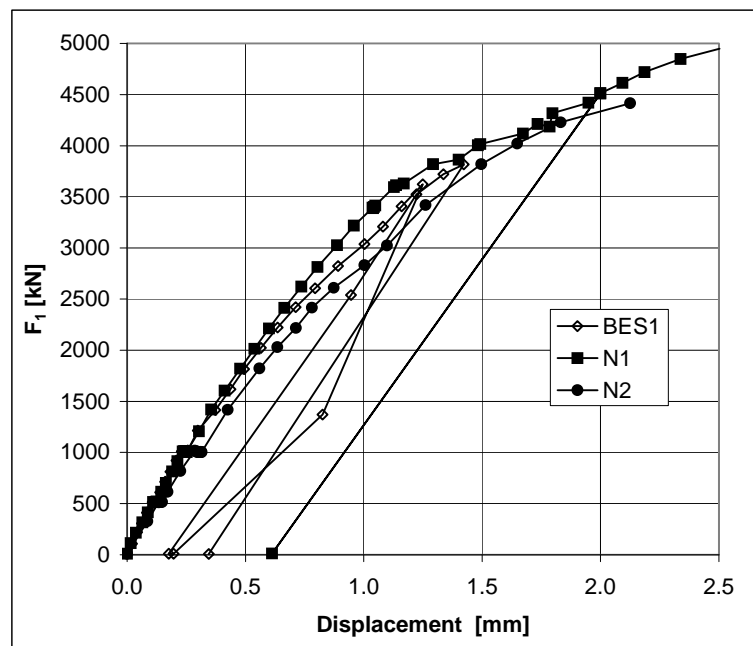
The vertical displacement of the upper wall element was measured by symmetrically positioned transducers 26 – 29. The measured maximum values before failure were of the order of 3 – 4 mm, i.e. of the order of the thickness of the neoprene strips in tests N1 and N2. The mean of the measured values can be regarded as the average displacement of the element. Fig 31 shows that virtually no difference can be seen in the vertical stiffness of the two tested joint types.

Fig. 31. Vertical displacement of upper wall element (mean of values measured by transducers 26 – 29).

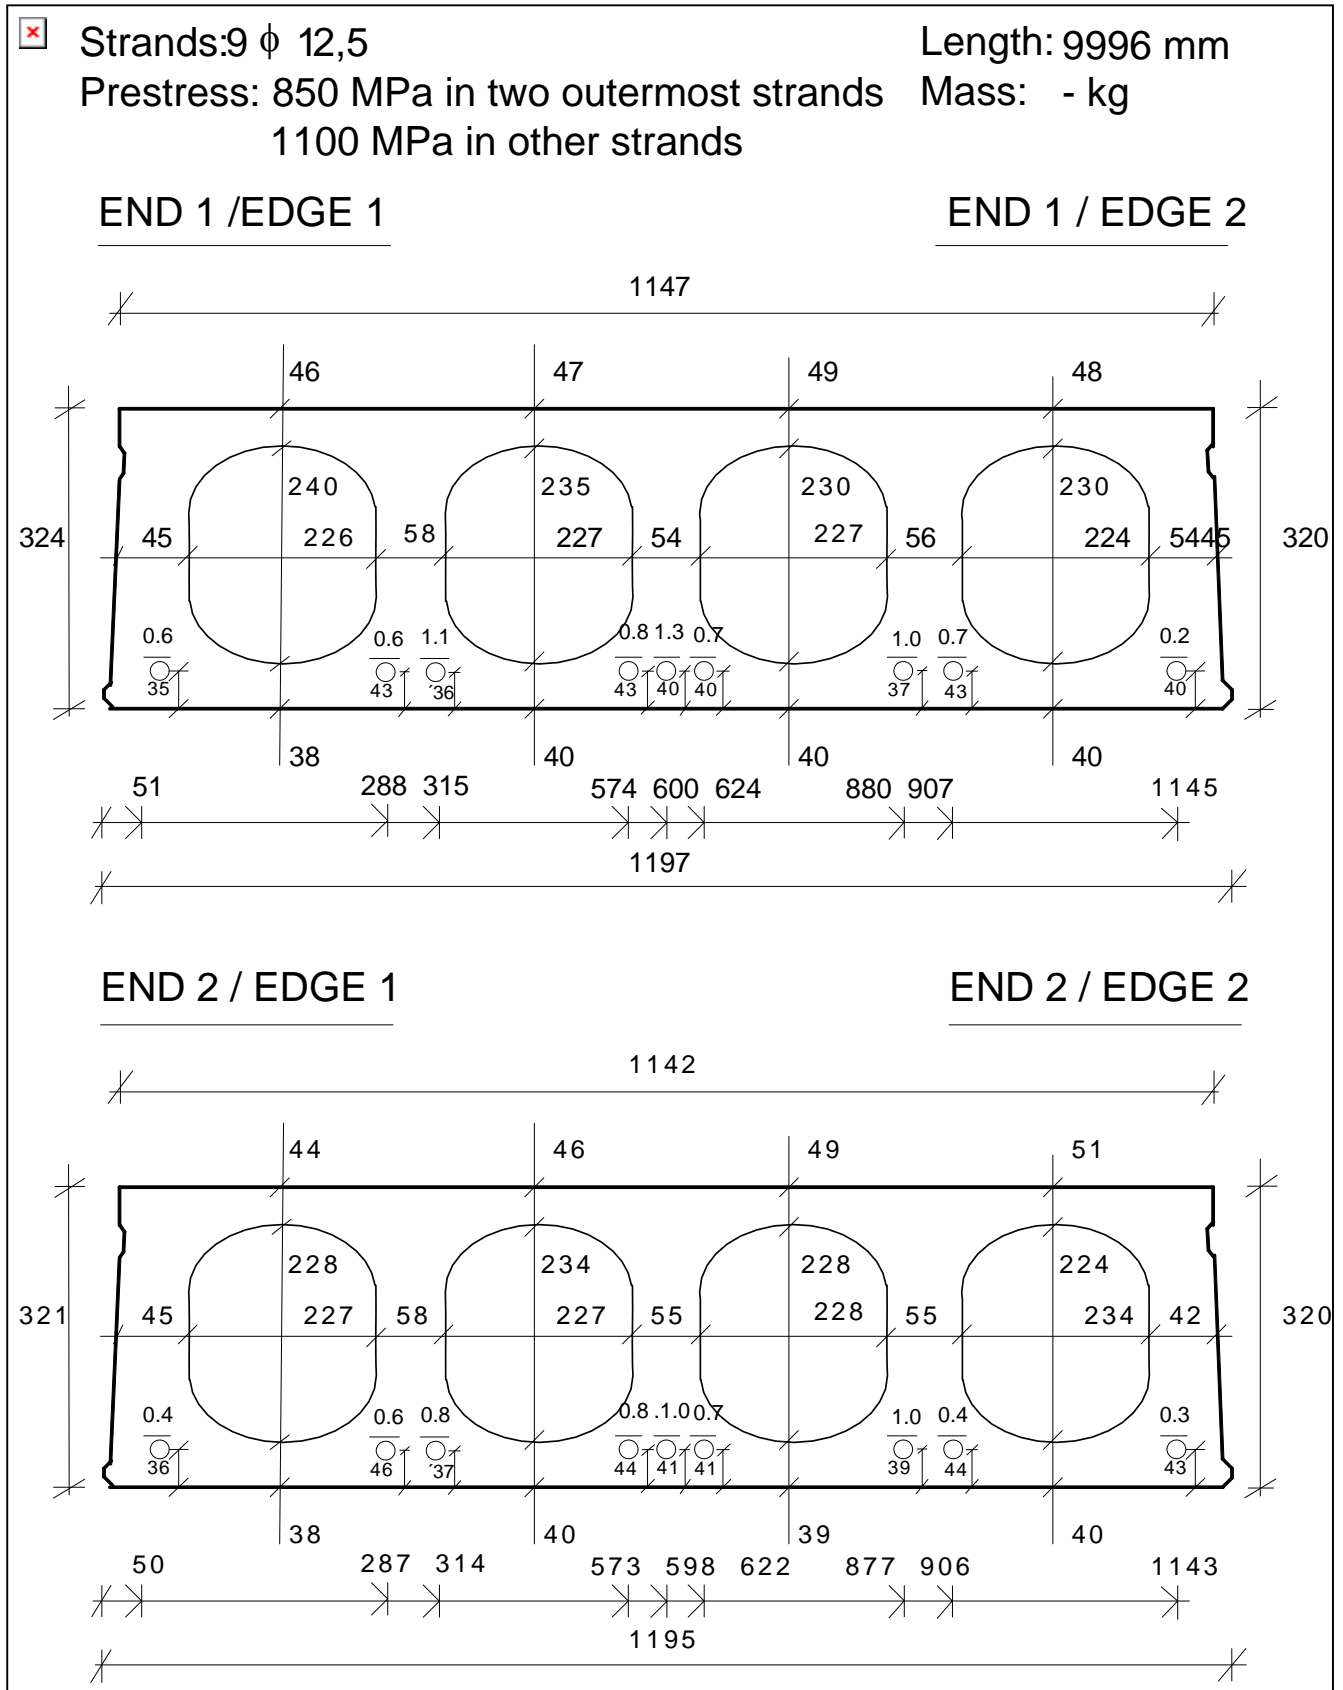
Fig. 6. Measured geometry and weight. Slab 5.

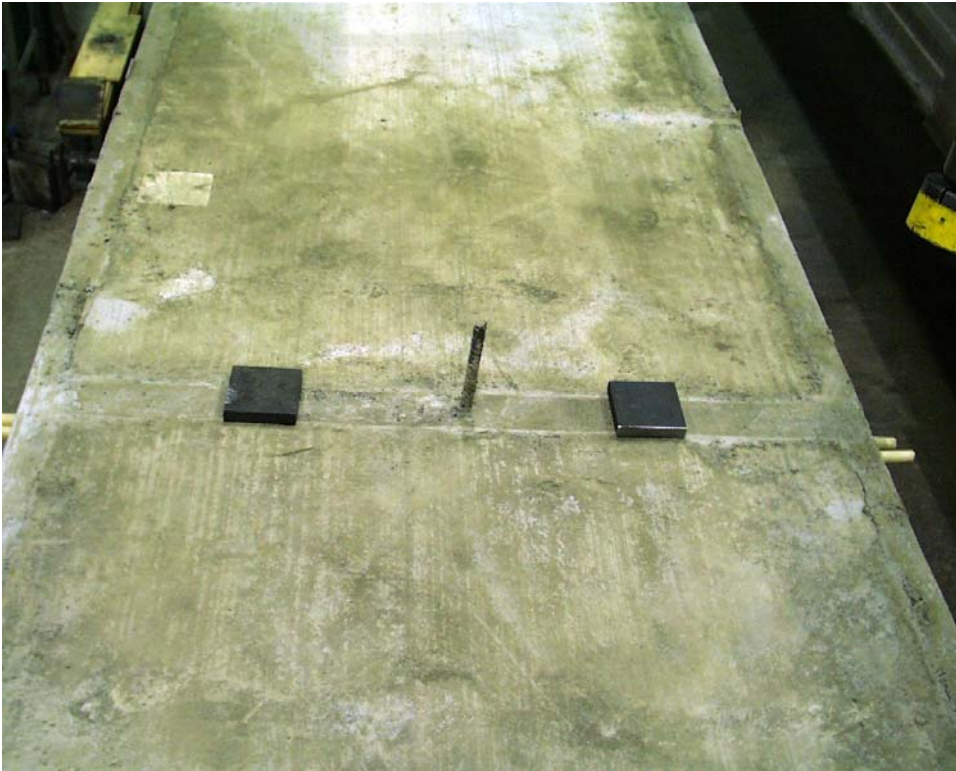
Fig. 3. Steel plates to support the upper wall element.

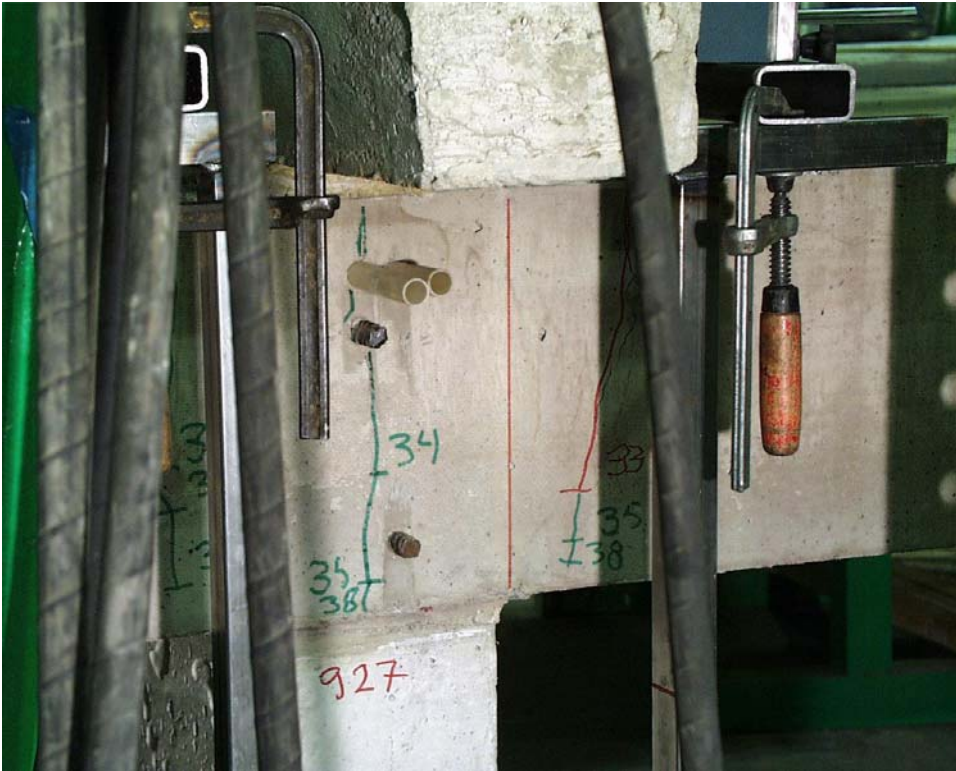
Fig. 7. Cracks at step 38 seen from north.

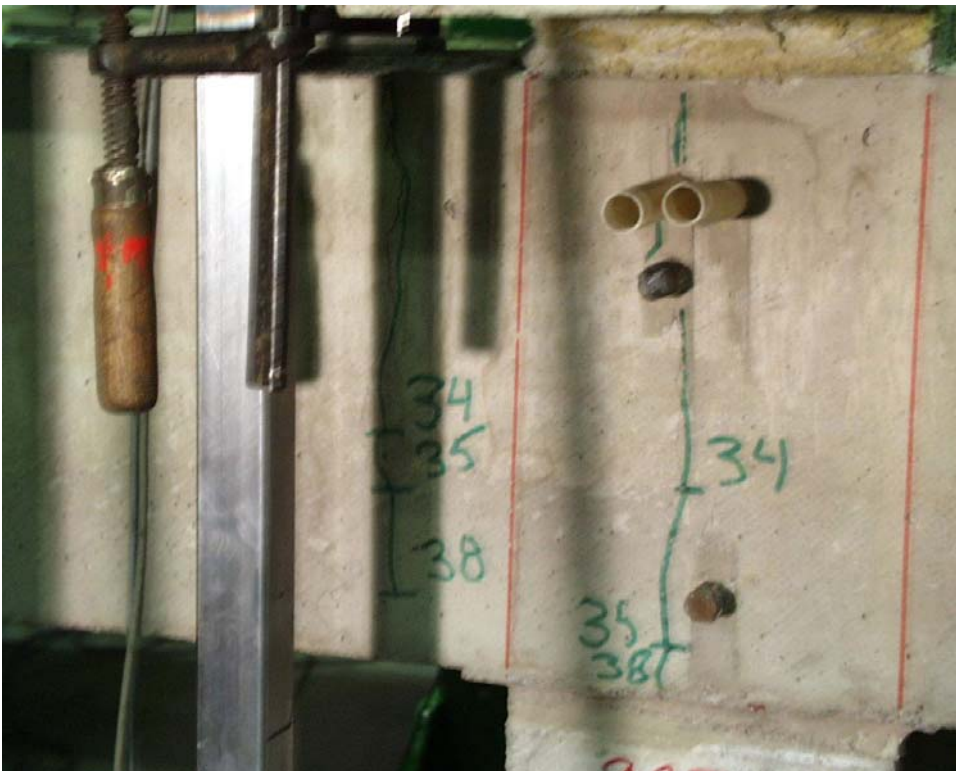
Fig. 8. Cracks at step 38 seen from north.

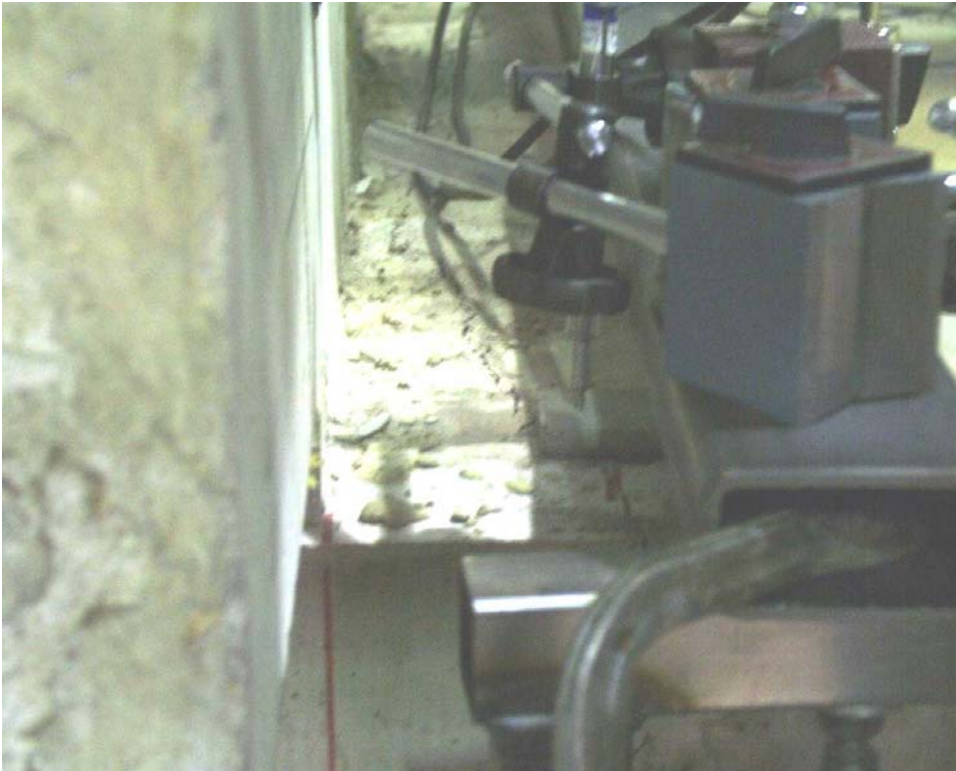
Fig. 9. Transverse crack on the top of the western slab at step 38.

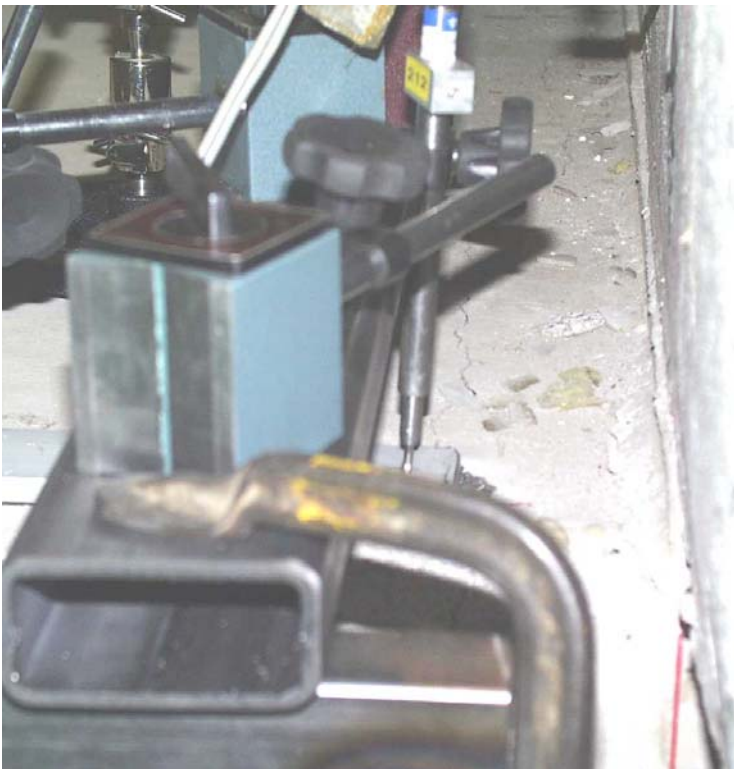
Fig. 10. Transverse crack on the top of the eastern slab at step 38.

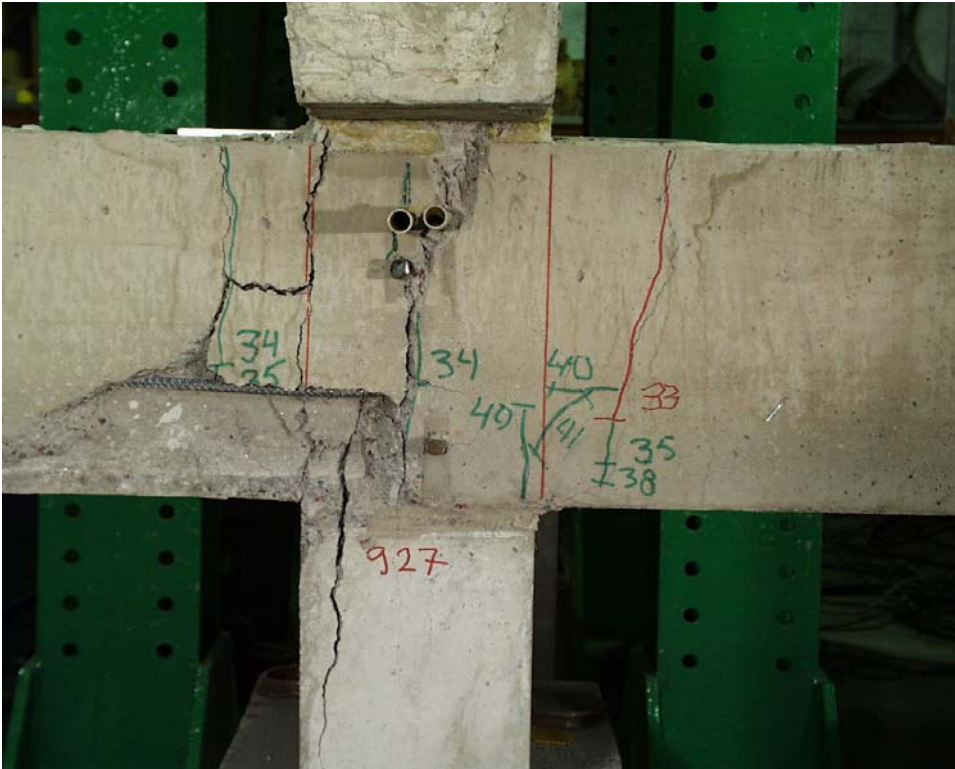
Fig. 11. Cracking pattern after failure seen from north.

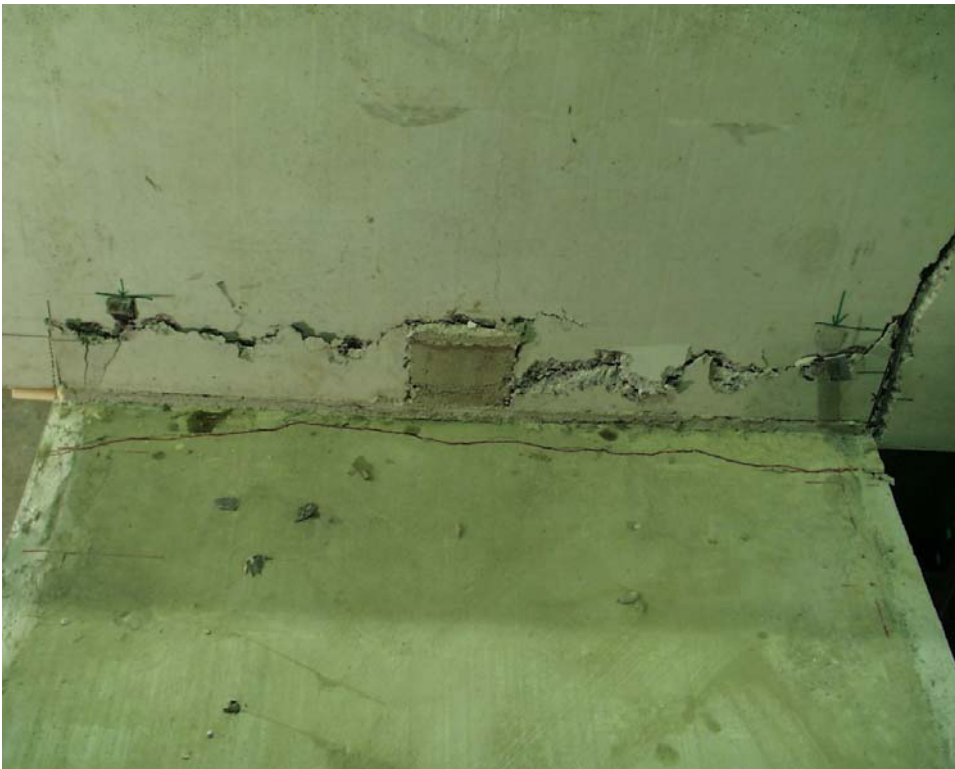
Fig. 12. Cracking pattern in the upper wall element after failure seen from west.

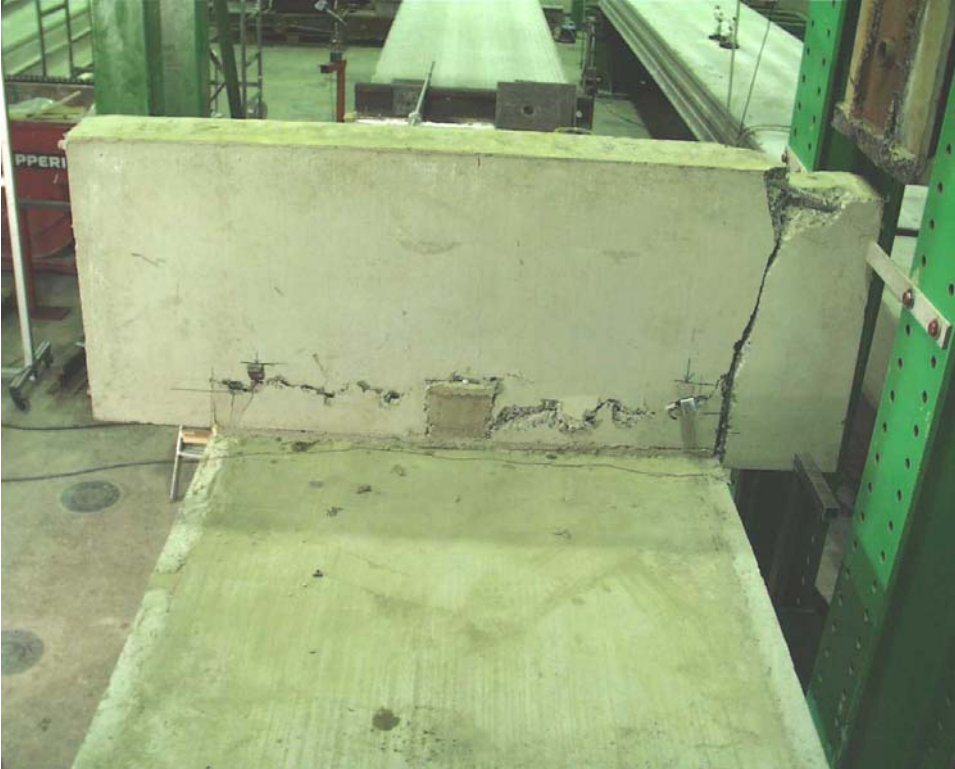
Fig. 13. Cracking pattern in the upper wall element after failure seen from west. Note also the failure of the cantilevered end which took place after step 44.

| Step | |
|---|--|
| 44 | After this step, upper wall element failed locally outside the joint, see fig. 13 in App. 6, unloading, 3 actuators removed, reloading |

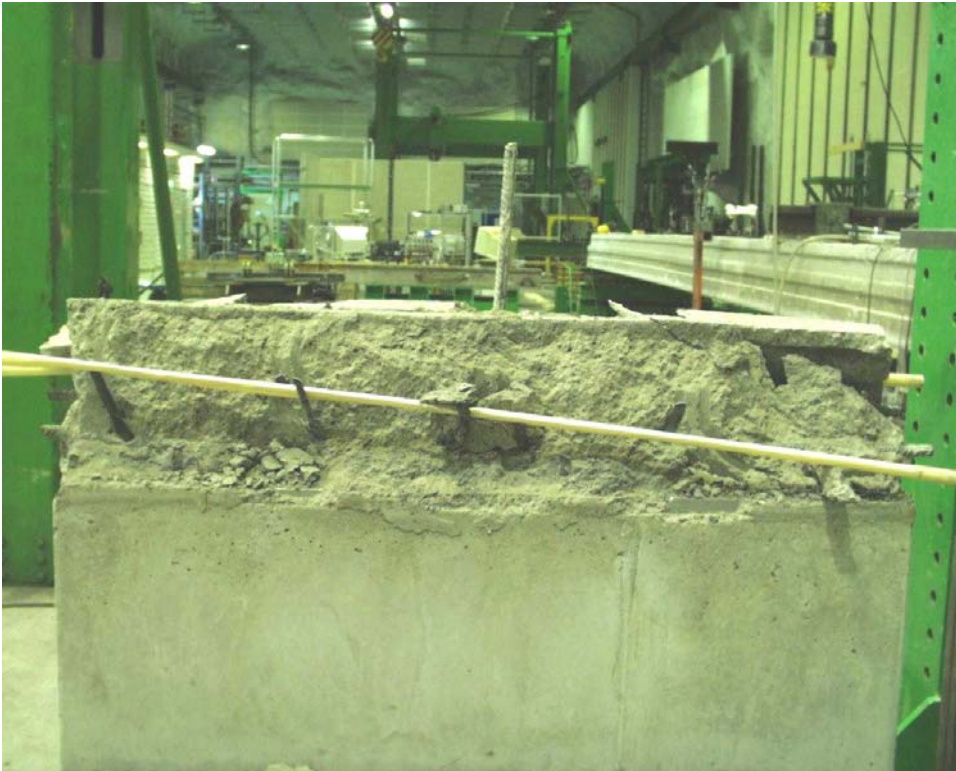
Fig. 17. Lower wall element after removal of slab seen from west.

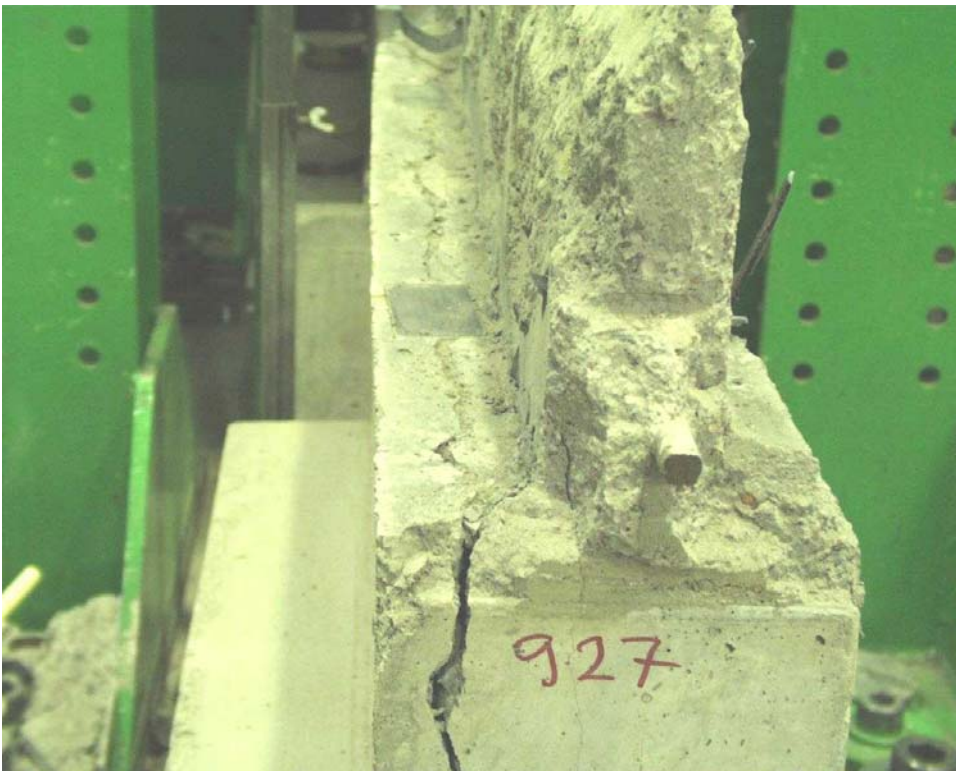
Fig. 18. Uncracked joint concrete on top of the upper wall element seen from north.

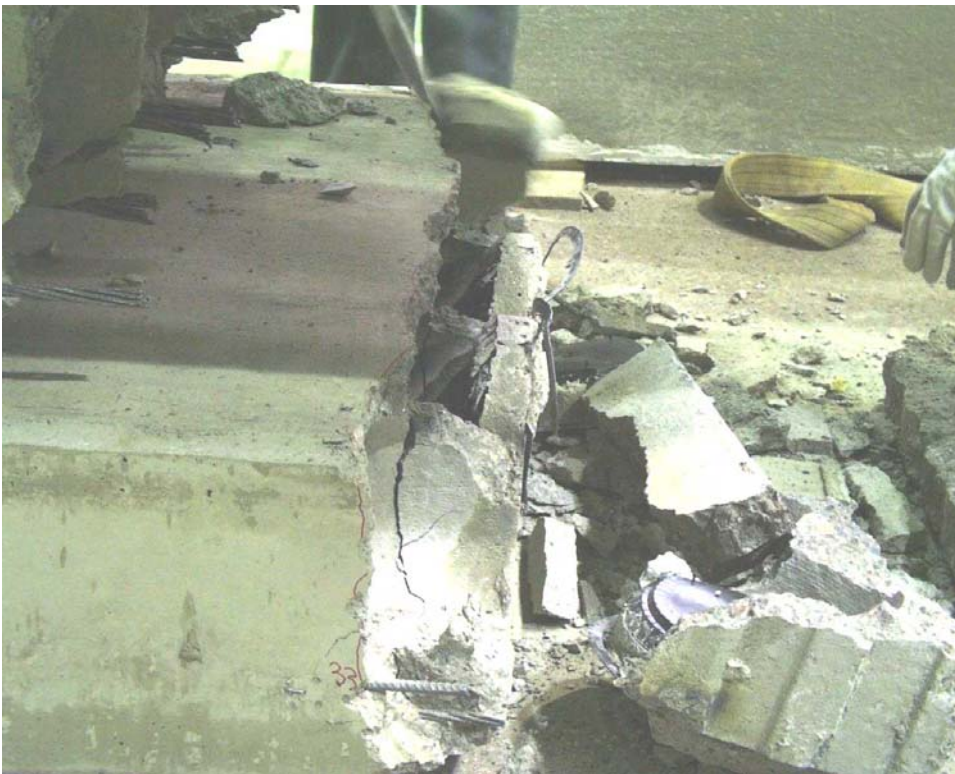
Fig. 20. End of western slab.

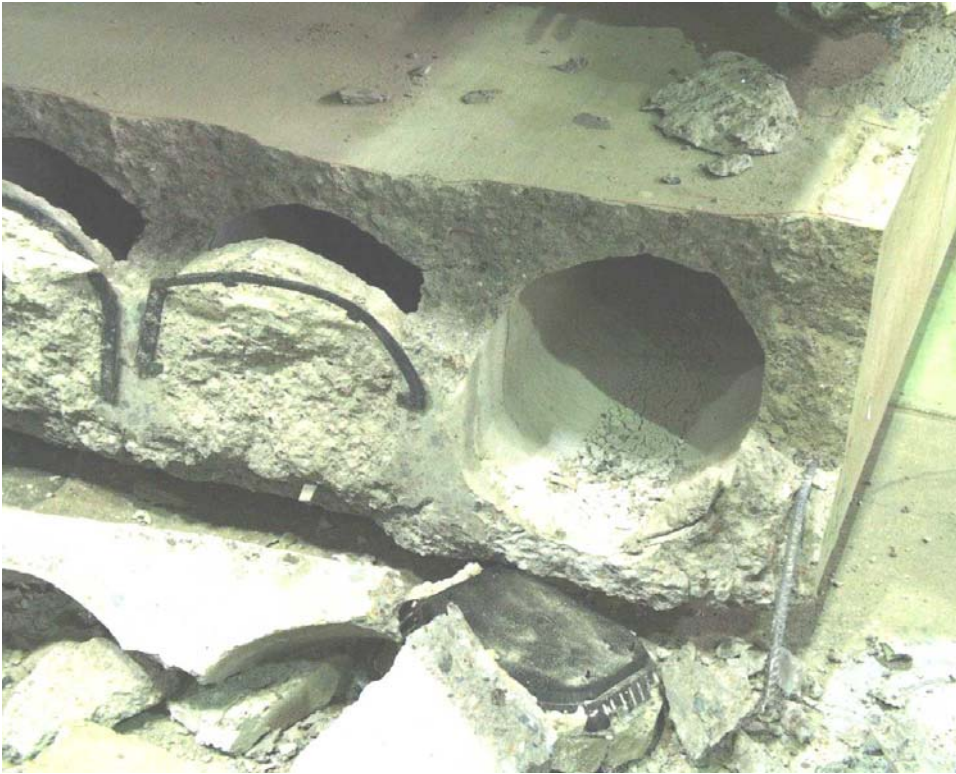
Fig. 21. End of western slab.

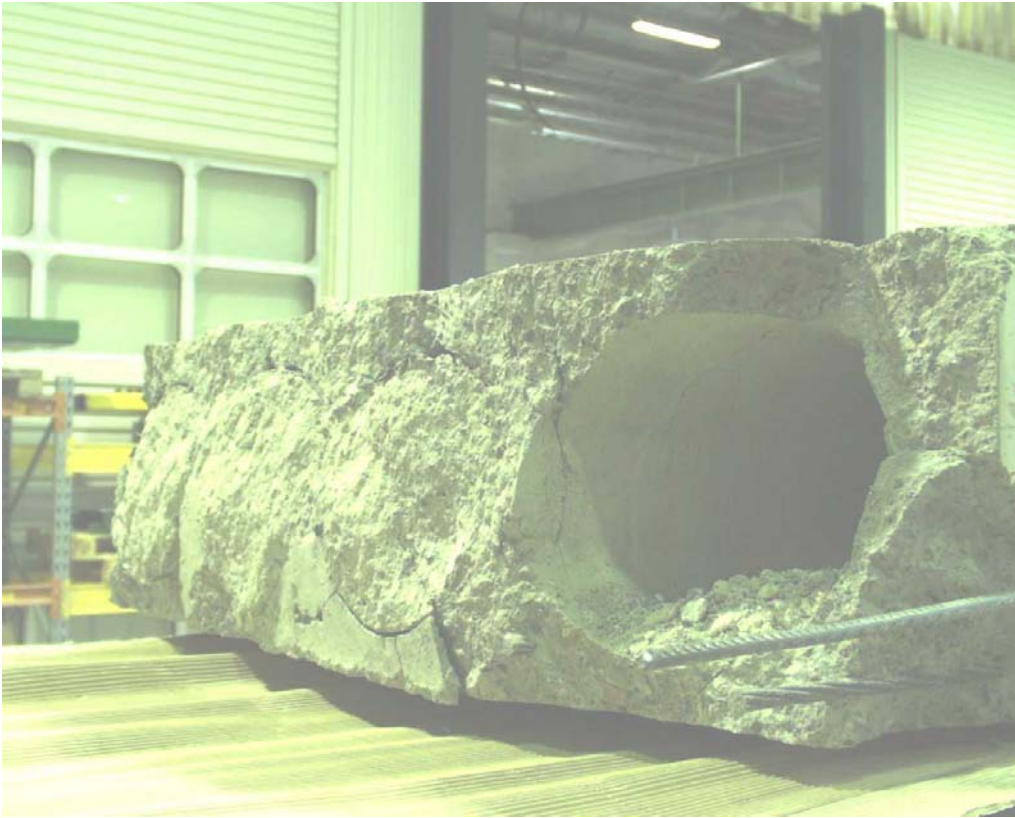
Fig. 23. End of eastern slab.

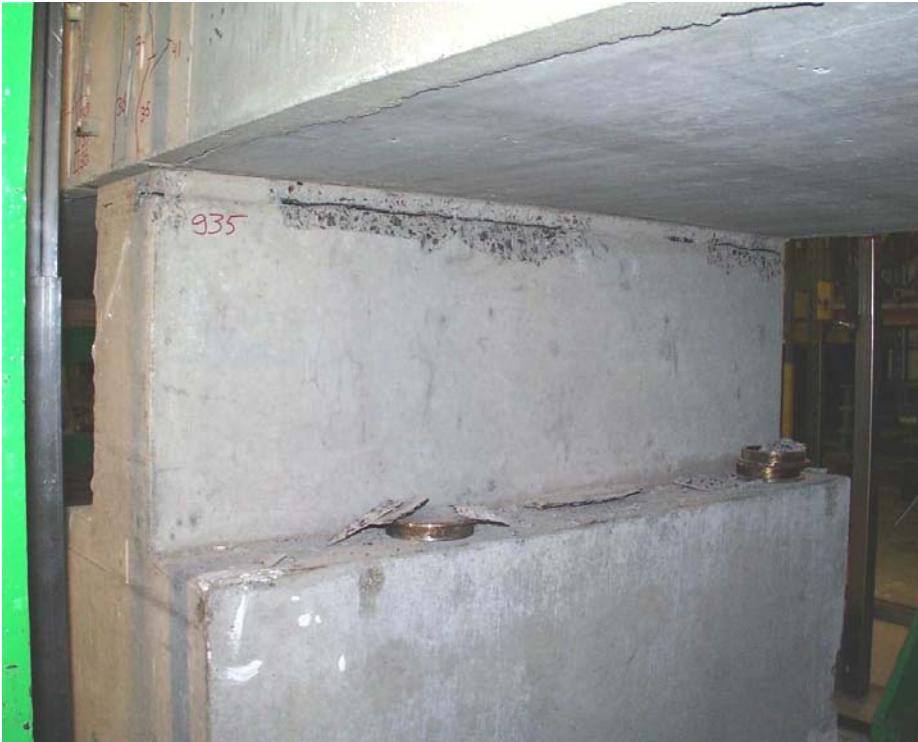
Fig. 7. Peeling of the concrete below and above the neoprene strip before failure seen from west.

| 44 | Strong deformation in neoprene, peeling of concrete in lower wall element outside the neoprene strip, see Fig. 7 in App. 7 |

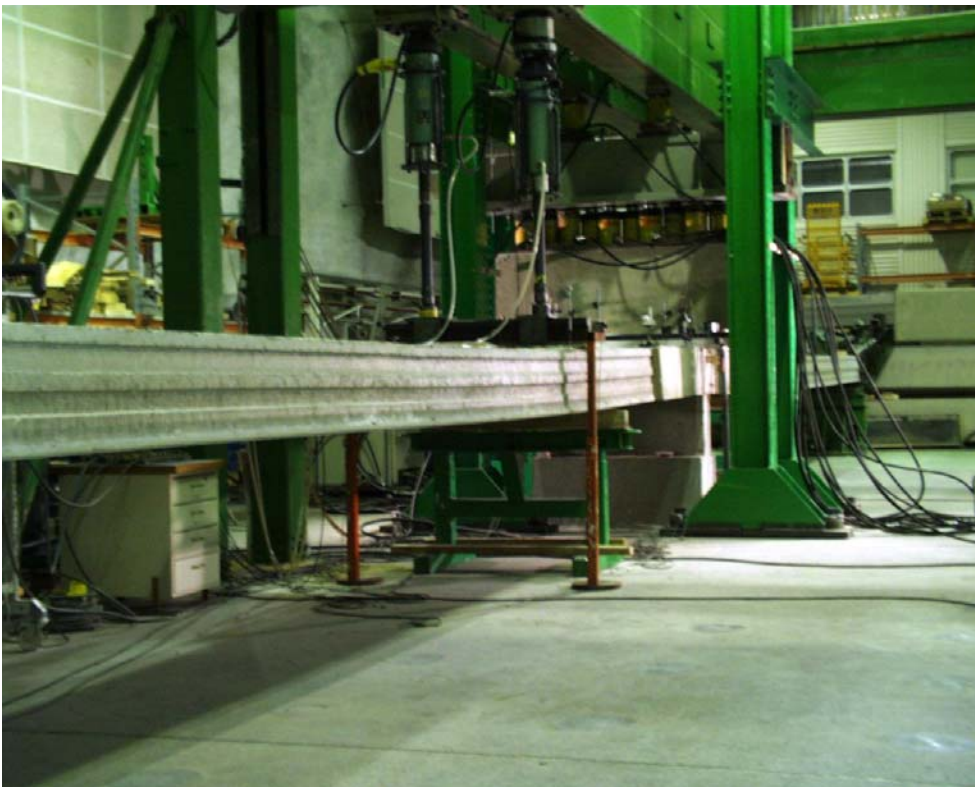
Fig. 8. Deformation of the eastern slab before failure.

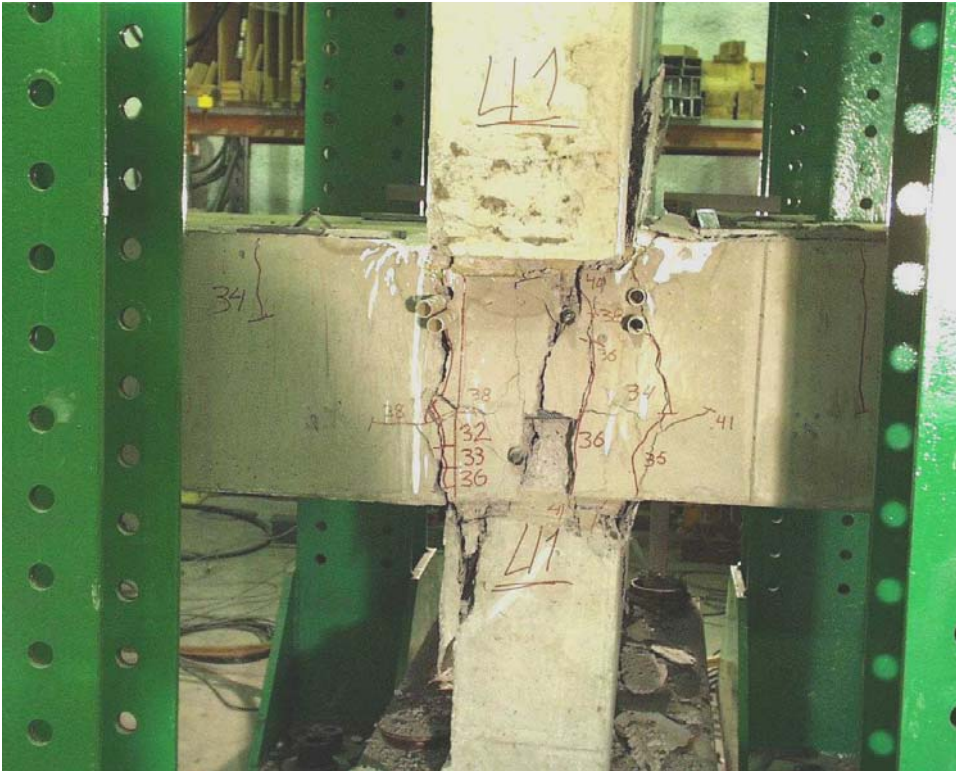
Fig. 9. Cracking pattern after failure seen from north.

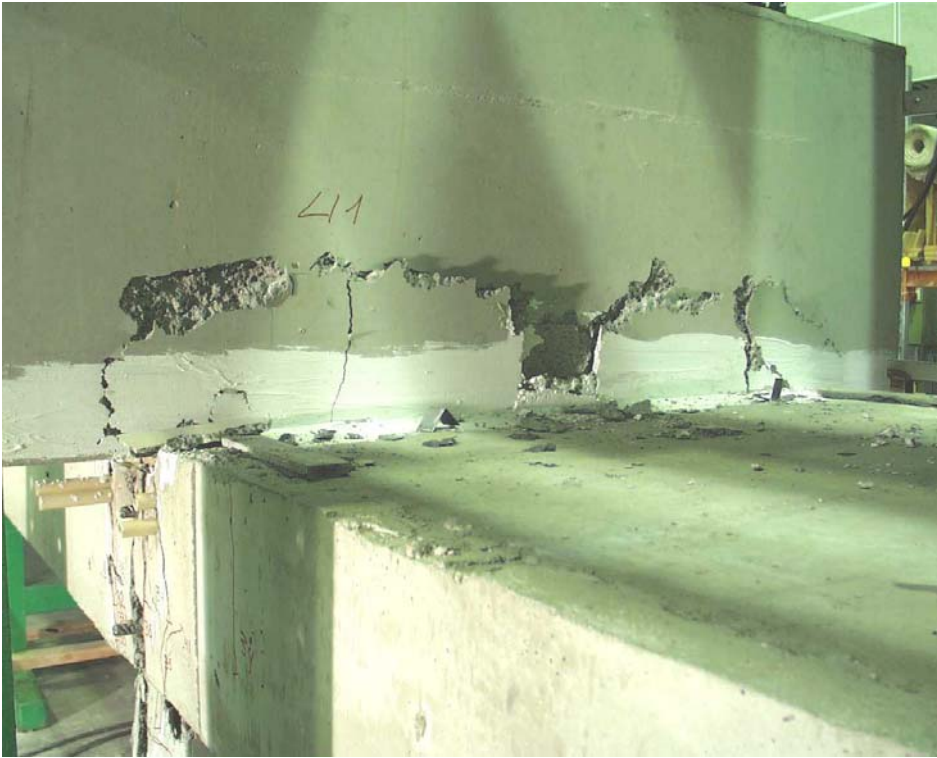
Fig. 11. Upper wall element after failure seen from west.

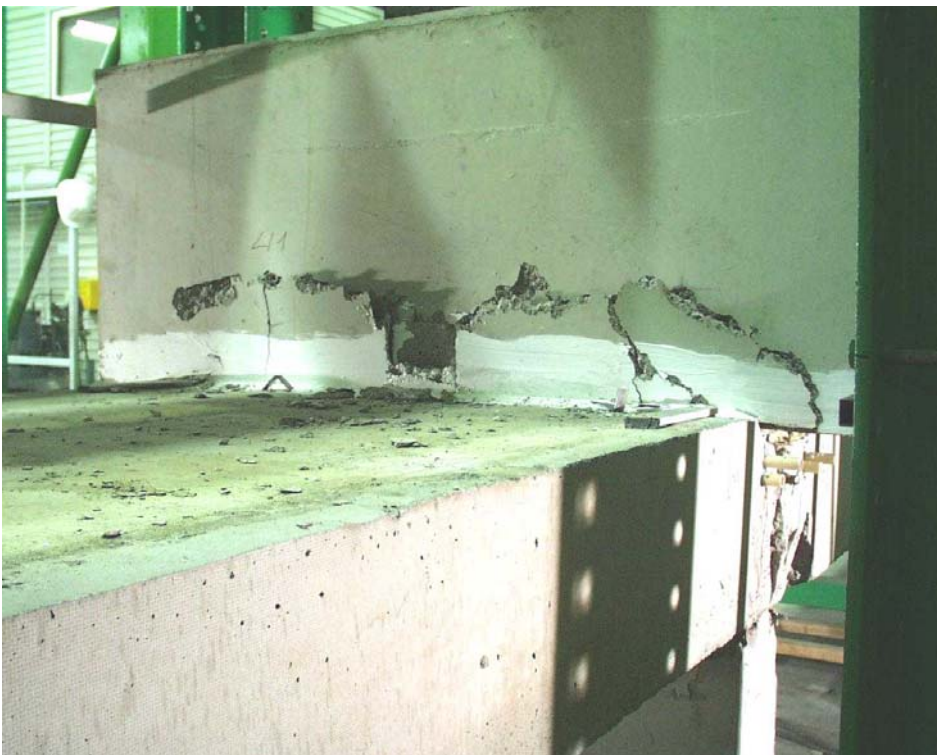
Fig. 12. Upper wall element after failure seen from west.

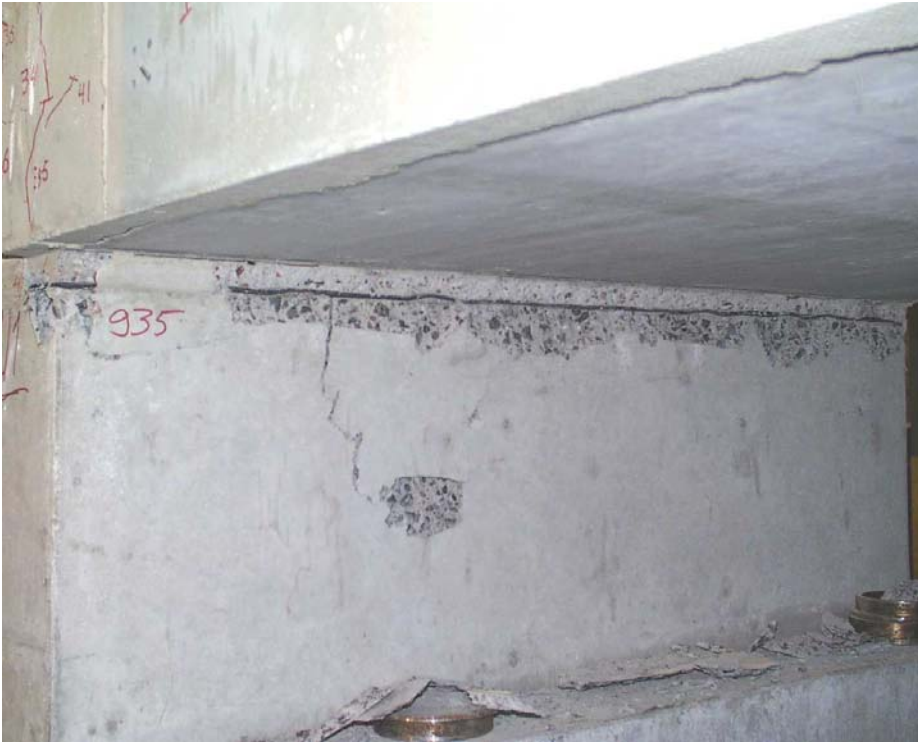
Fig. 13. Lower wall element after failure seen from west.

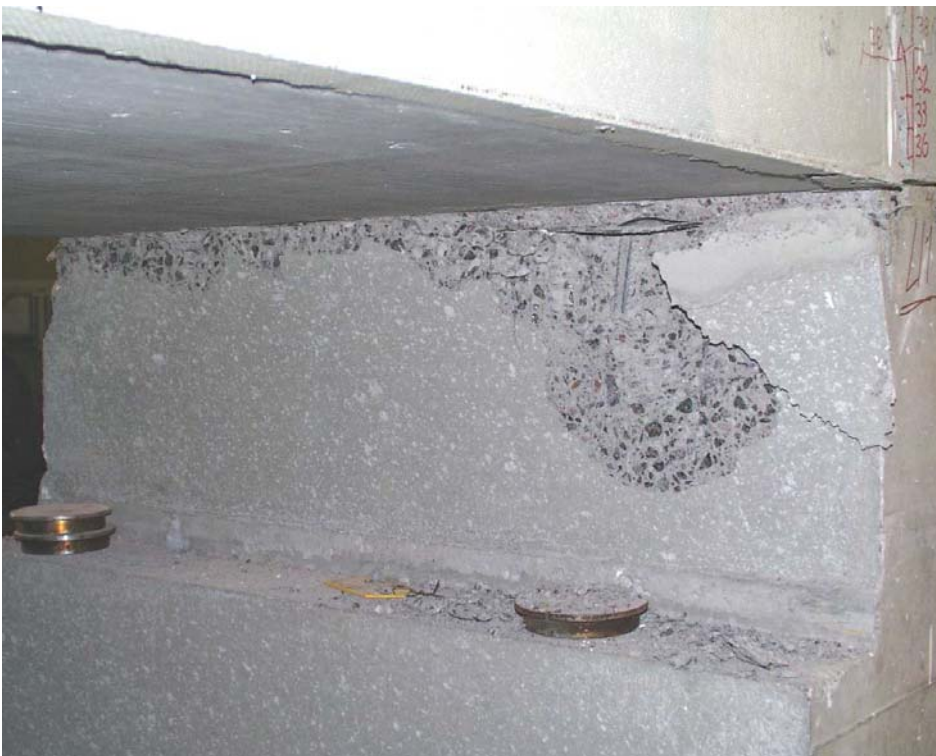
Fig. 14. Lower wall element after failure seen from east.

As can be seen in Fig. 20, the west side of the upper wall element moved down faster than the east side. At failure, the upper edge of the lower wall element on the west side and the lower edge of the upper wall element on the east side failed simultaneously (see Figs 4 and 14 in App. 7). The failure was rather brittle.

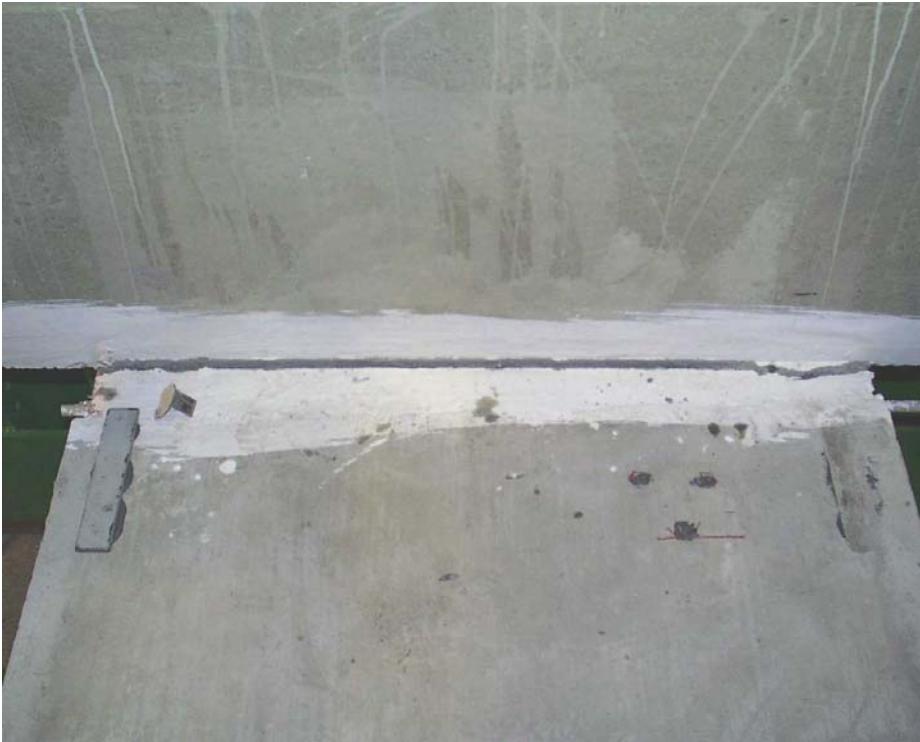
Fig.15. Uncracked eastern face of the upper wall element after failure.

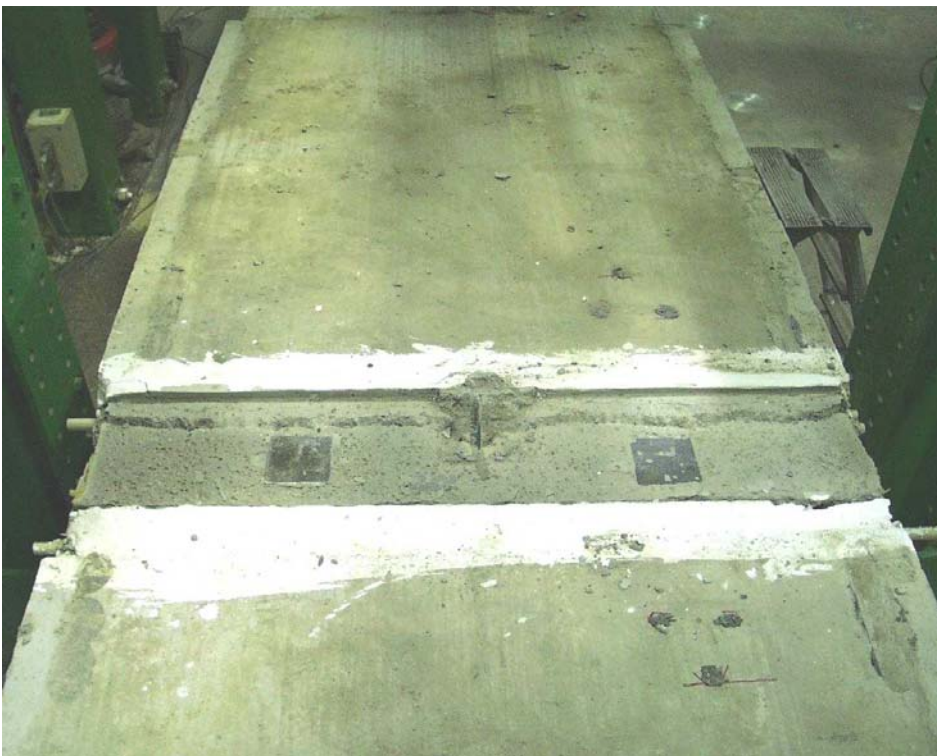
Fig. 16. Top surface of the joint after removal of the upper wall element.

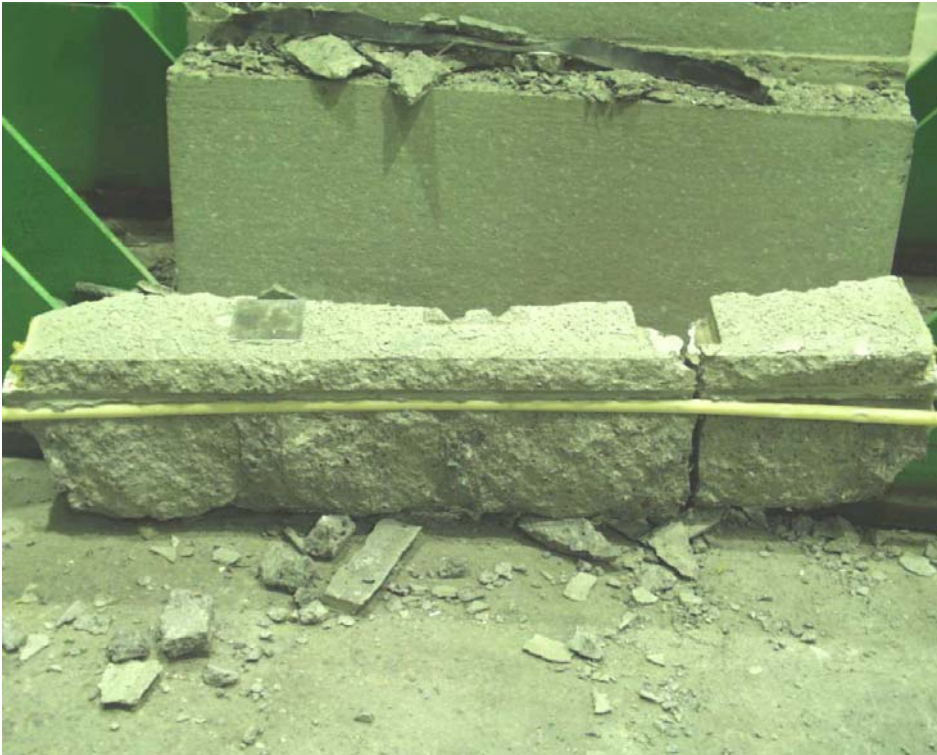
Fig. 21. A monolithic block (joint concrete) which was broken when falling down from the top of the lower wall element, seen from east.

The failure mode of the lower wall element (uncracked between the slab ends, cracked below the neoprene) suggests that the load was mainly transmitted by the slab ends and neoprene, not by the jointing grout between the slab ends. This observation is supported by the strong deformation of the neoprene illustrated in Figs 20 and 21 in App. 7.

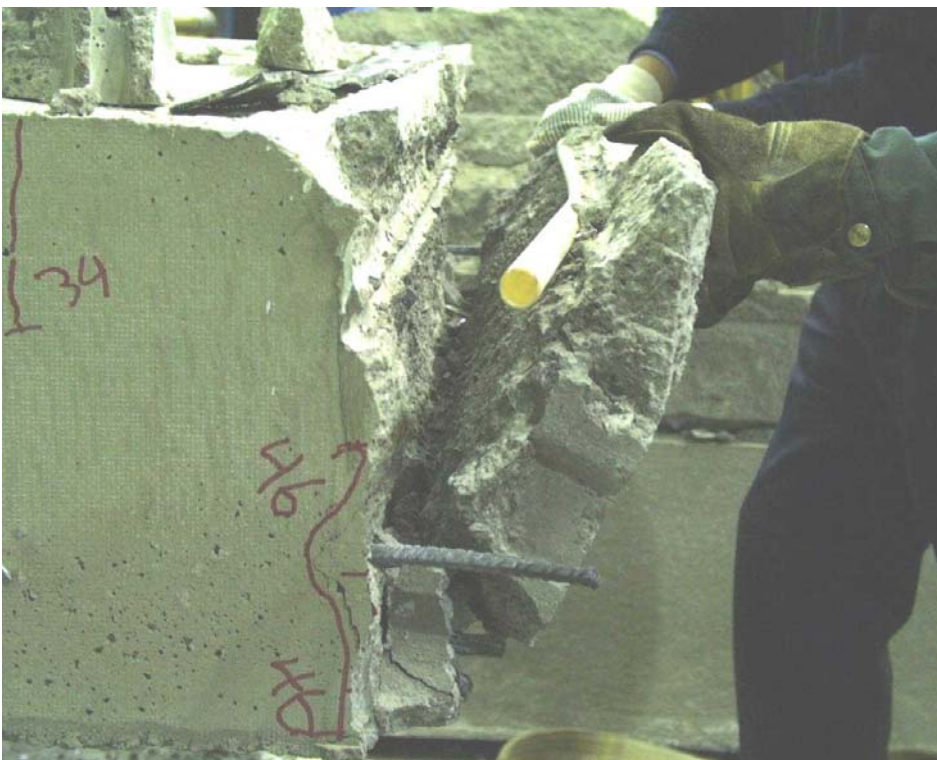
Fig. 22. Removing a concrete block from end of western slab.

The cracking mode of the slab ends shown in Figs 22 -25 in App. 7 was of the unfavourable type.

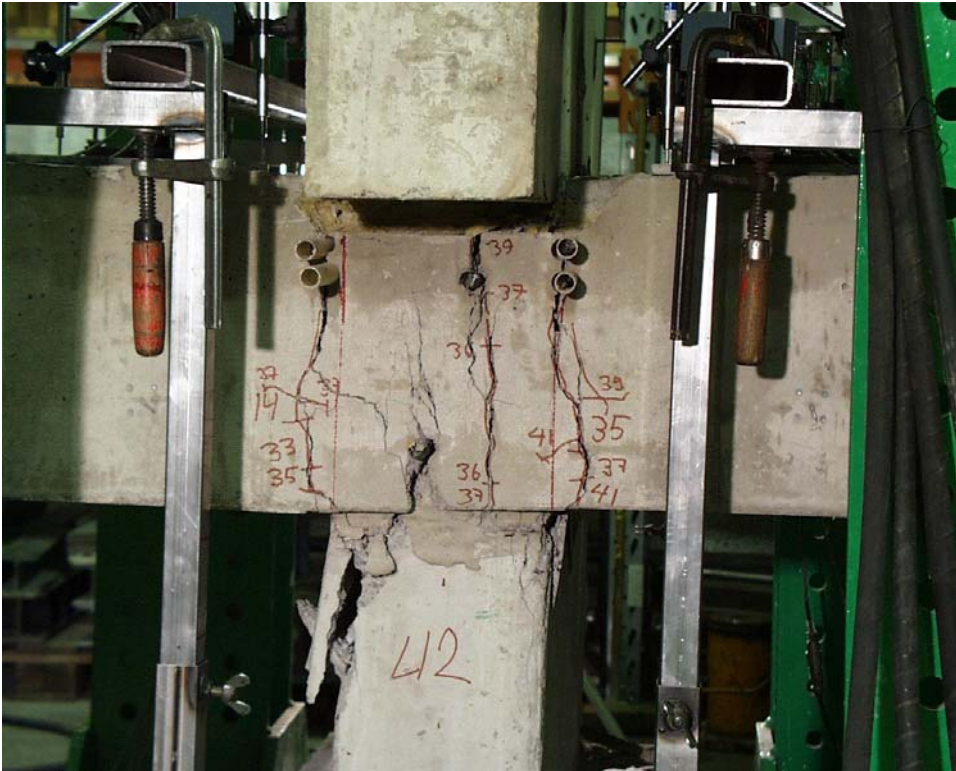
Fig. 3. Cracking pattern at failure seen from north.

As can be seen in Fig. 26, the west face of the upper wall element moved down faster than the east face. At failure, the upper edge of the lower wall element on the east side and the lower edge of the upper wall element on the west side failed simultaneously, see Figs 3, 4 and 7 - 11 in App. 8. The failure was rather brittle.
