RESEARCH REPORT NO. RTE77/02

Experimental research on wall-slab connections

Requested by: Rakennustuoteteollisuus r.y.

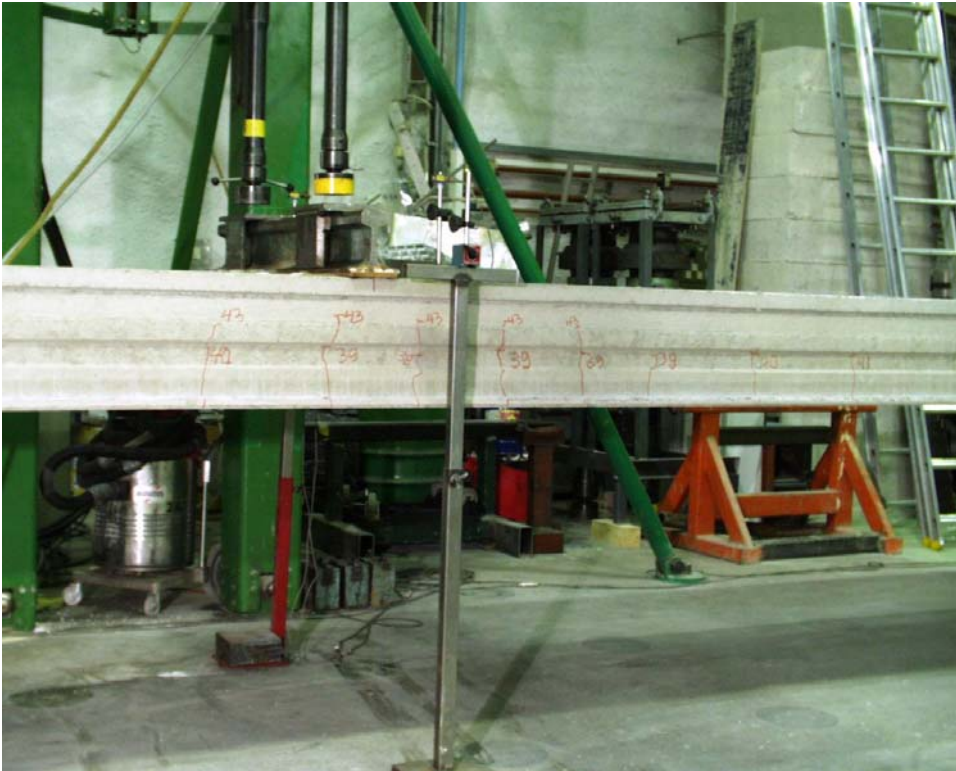
Fig. 5. Location of flexural cracks in western slab.

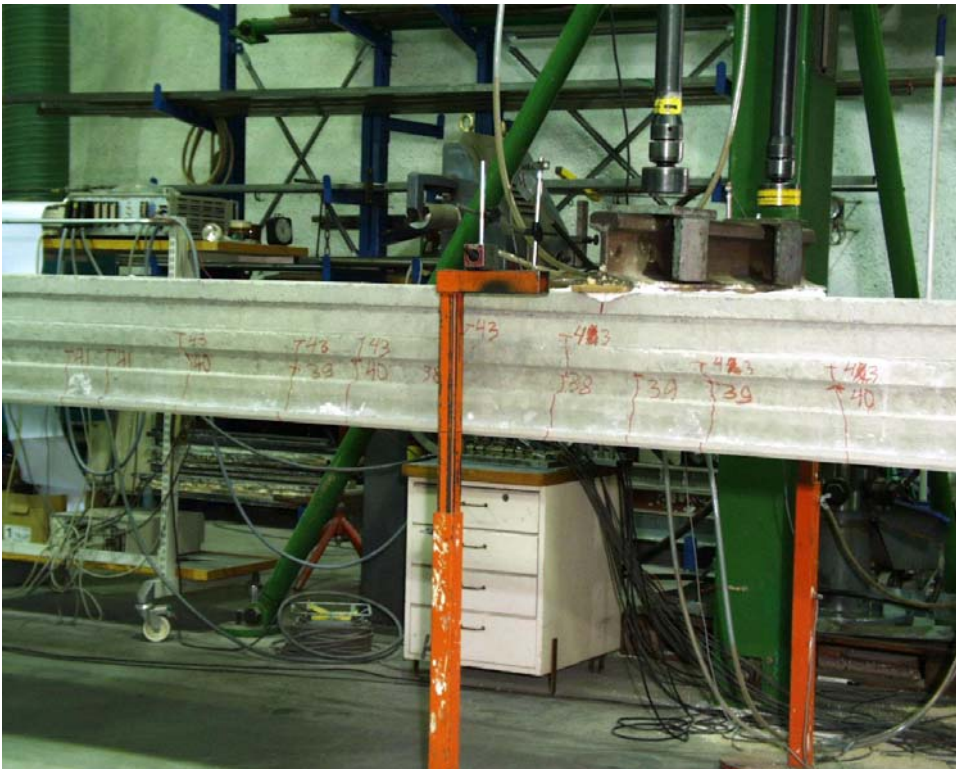
Fig. 6. Location of flexural cracks in eastern slab.

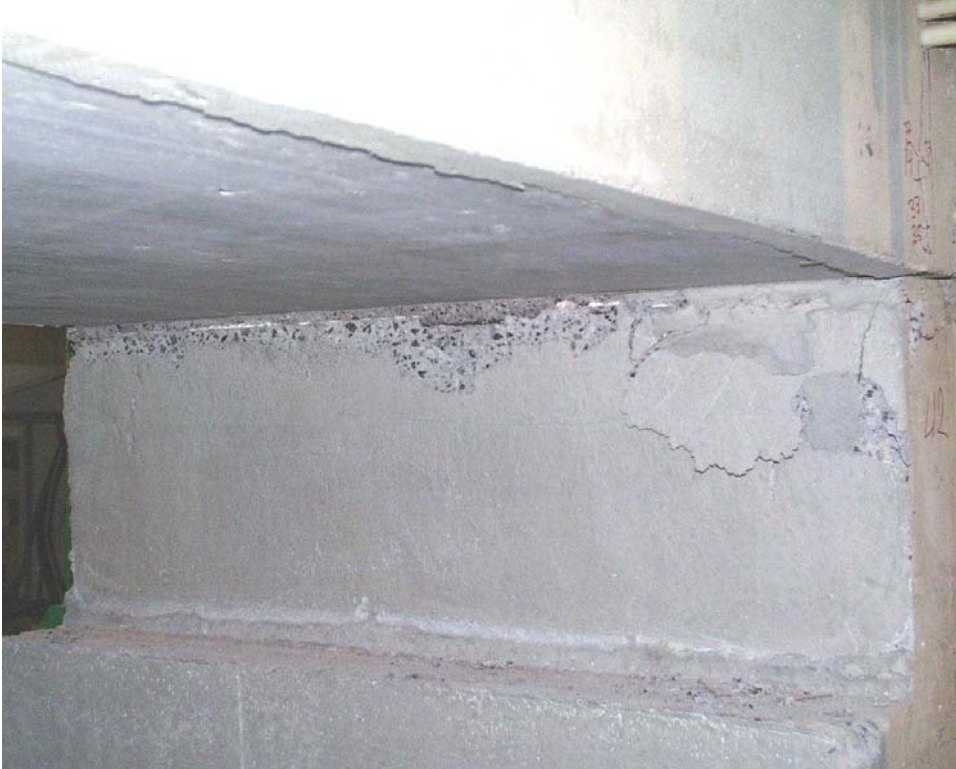
Fig. 7. Peeling of concrete in lower wall element seen from east.

As can be seen in Fig. 26, the west face of the upper wall element moved down faster than the east face. At failure, the upper edge of the lower wall element on the east side and the lower edge of the upper wall element on the west side failed simultaneously, see Figs 3, 4 and 7 - 11 in App. 8. The failure was rather brittle.

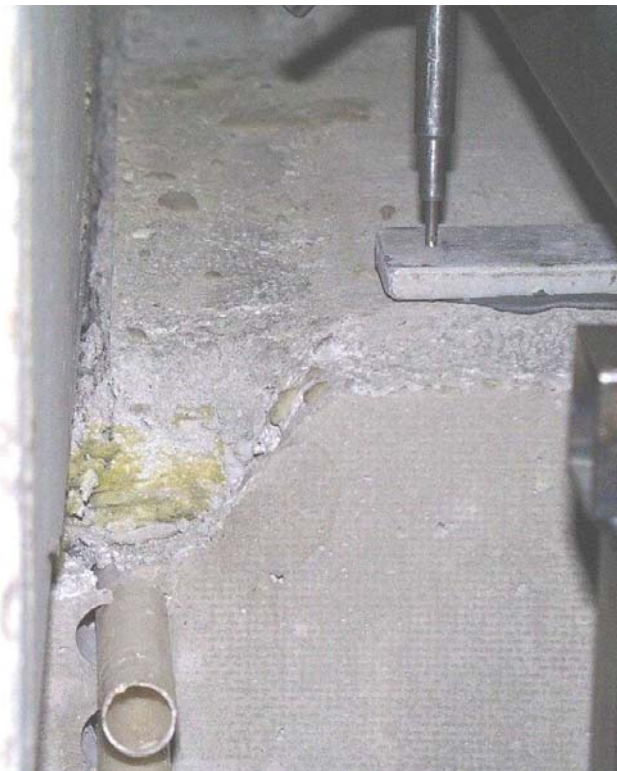
Fig. 10. No visible cracking in upper wall element after failure, seen from east.

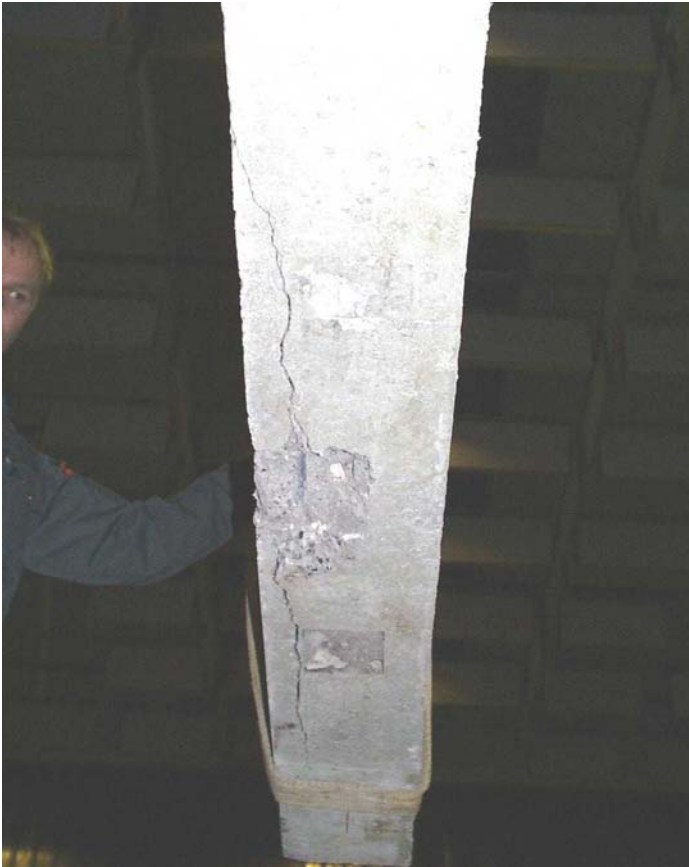
Fig. 11. Cracking pattern in upper wall element. Western face on the left.

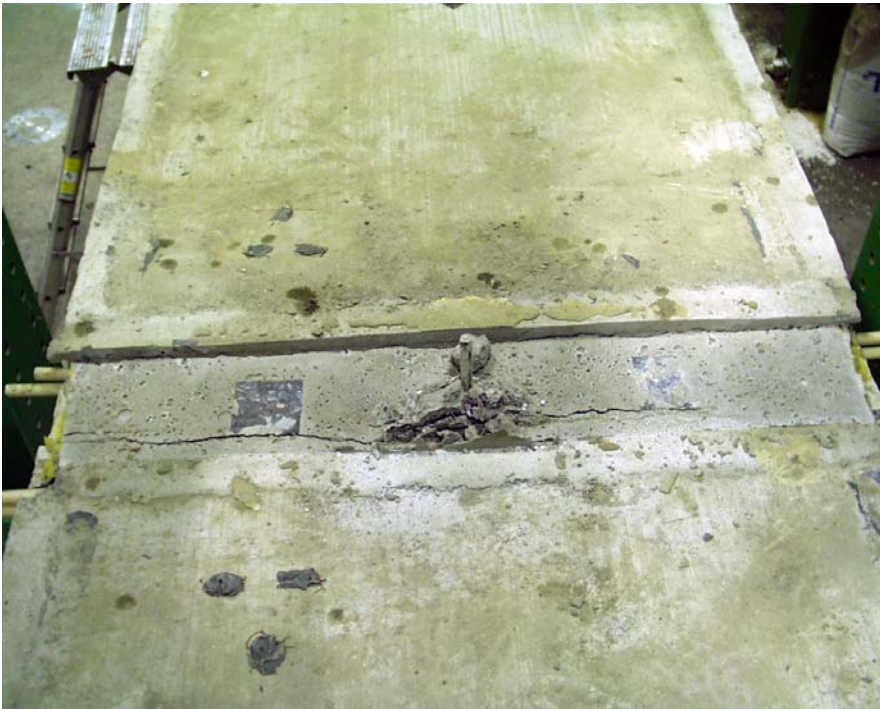
Fig. 12. Joint after removal of the upper wall element seen from west.

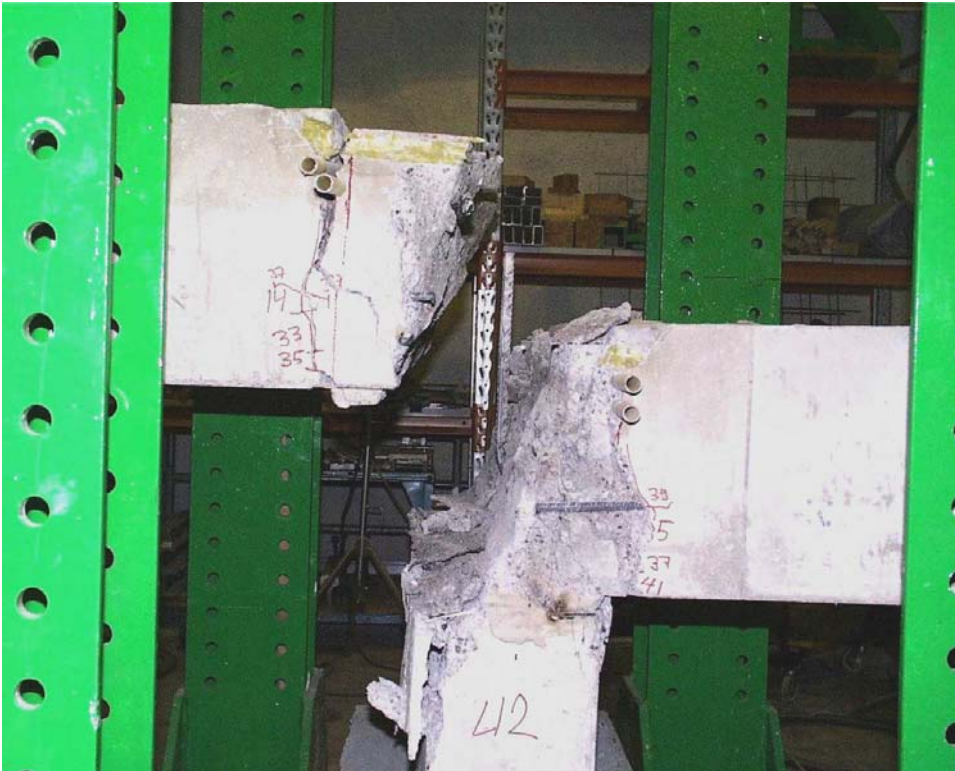
Fig. 13. Removal of the failed slab seen from north.

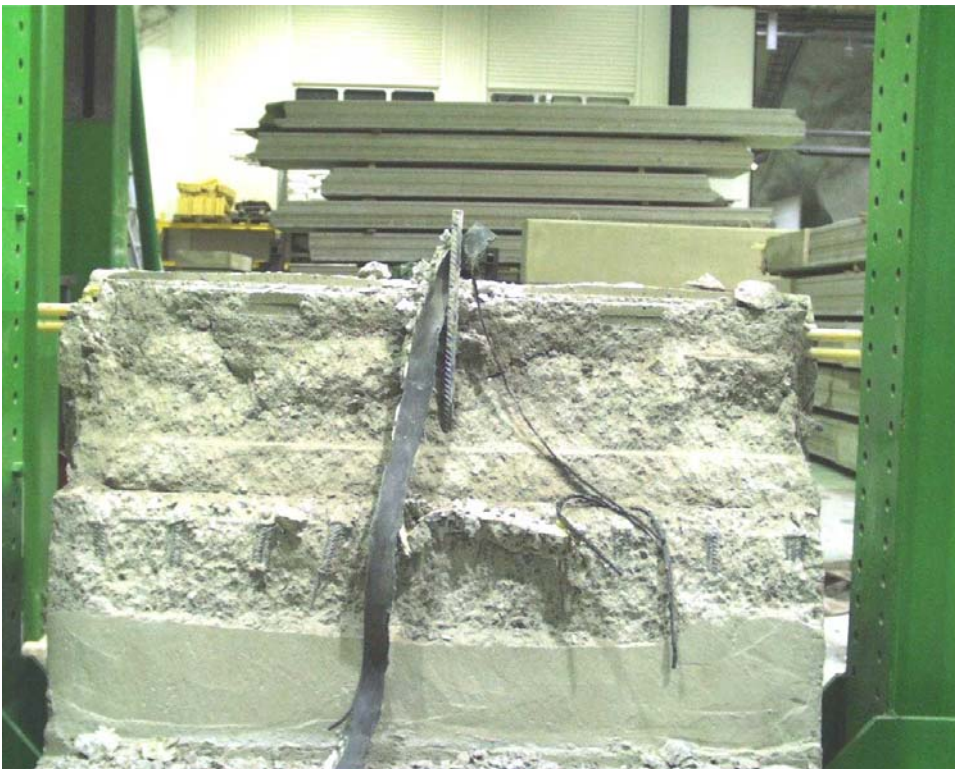
Fig. 14. Lower wall element seen from east.

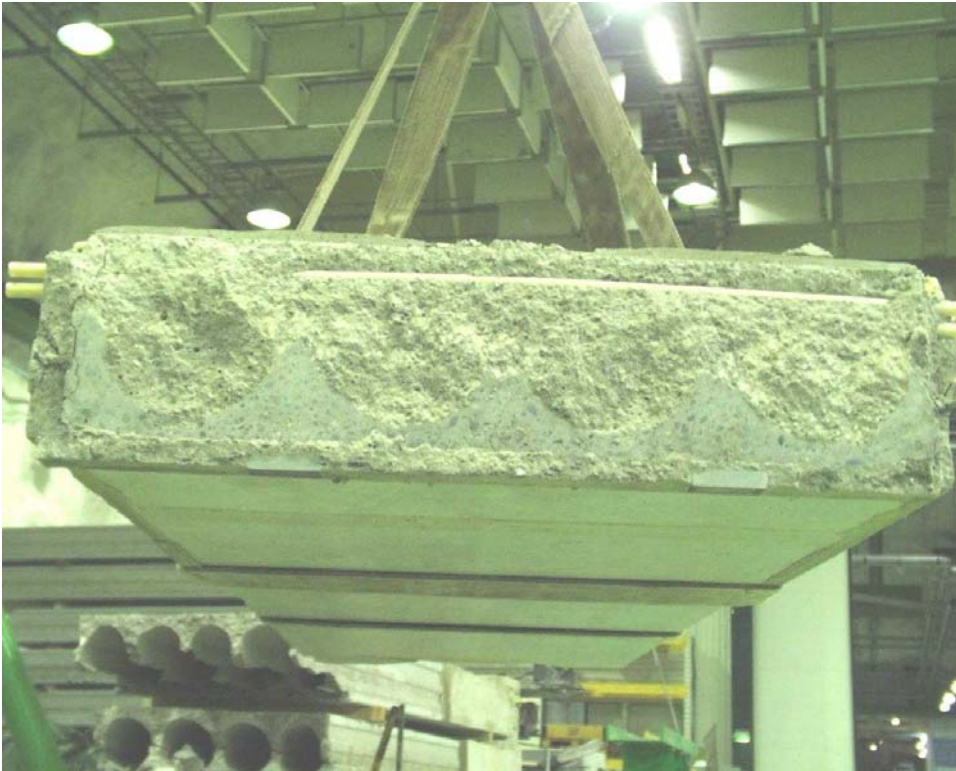
Fig. 15. End of western slab.

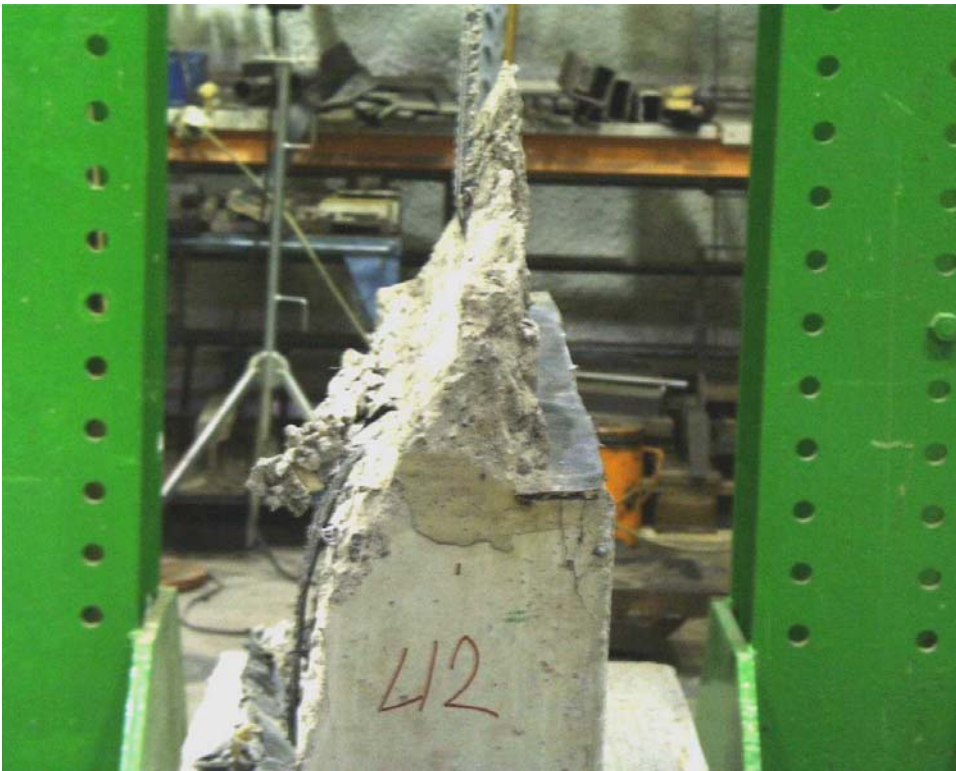
Fig. 16. Lower wall element seen from north.

It has been proposed that the grout between the slab ends is in an essentially three-dimensional stress state and, therefore, has a compressive strength of the order of 2.5 times its uniaxial strength. The vertical cracks in the middle of the joint and on both sides of the joint did not support this hypothesis. On the other hand, a ridge of the grout survived the failure uncracked, see Figs 15 – 19, 19 - 20 and 16 - 18 in Appendices 6, 7 and 8, respectively.

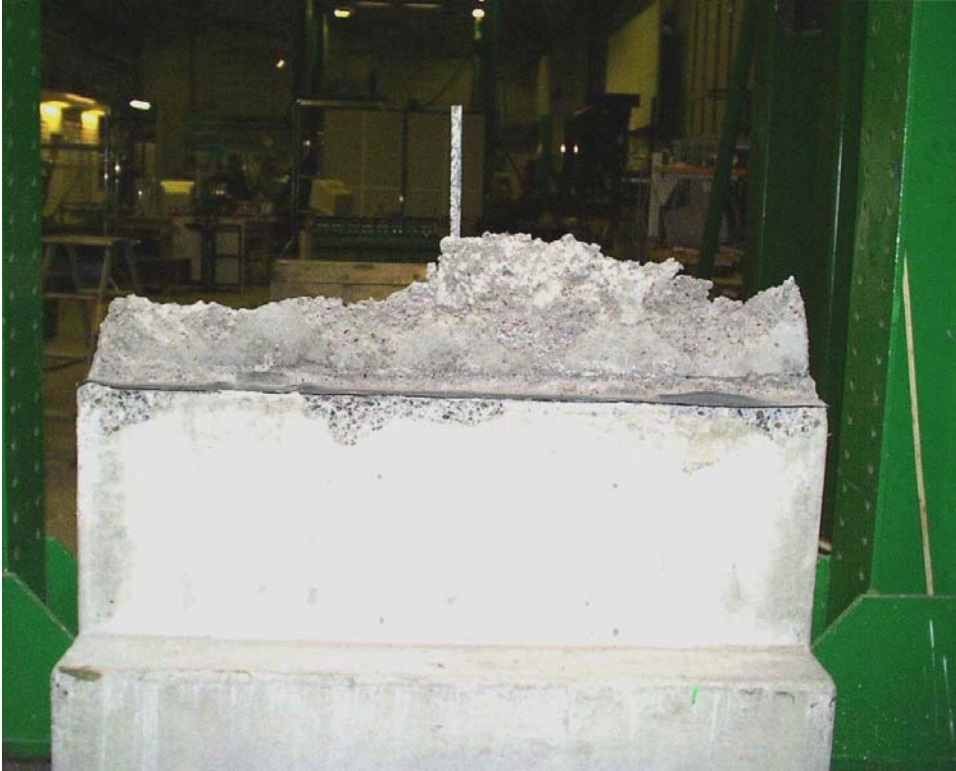
Fig. 17. Lower wall element seen from west.

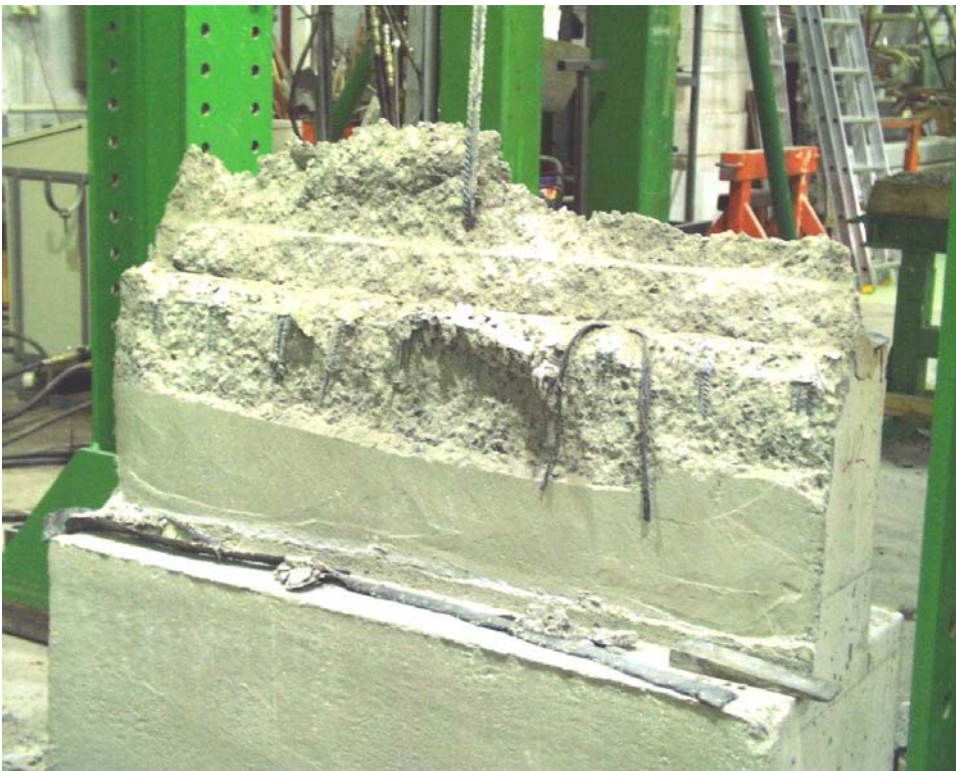
Fig. 18. Lower wall element seen from east.
